Wpływ deflektorów na warunki hydromorfologiczne panujące w małej rzece nizinnej na przykładzie rzeki Flinty

Impact of deflectors on hydromorphological conditions prevailing in a small lowland river on the case of the Flinta River

Rozprawa doktorska w dziedzinie nauk inżynierijno–technicznych
w dyscyplinie inżynieria, górnictwo i energetyka
Doctoral thesis in engineering and technology sciences
in the environmental engineering, mining and energy discipline

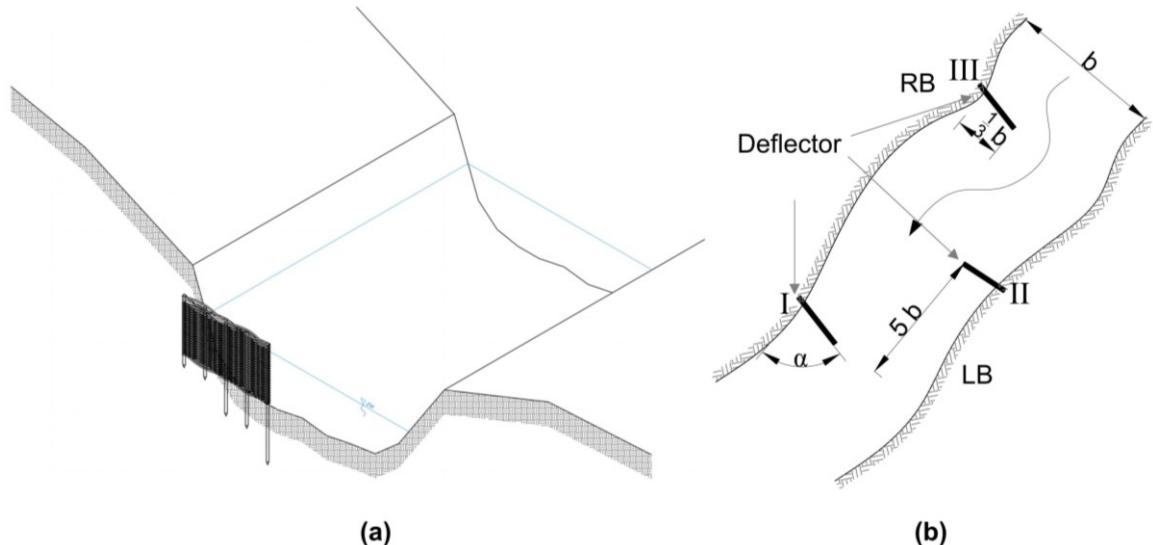
Ryc. 2. Schemat rozmieszczenia deflektorów na badawczym odcinku Flinty (Zaborowski i in. 2023)

W lokalizacji wskazanej na rycinie (Ryc. 1) zaprojektowano i wykonano 3 deflektory wiklinowe o konstrukcji ażurowej. Zostały one usytuowane w odległości 15 m od siebie, co mieściło się w proponowanym przedziale 5–7 szerokości koryta oraz przegradzały koryto w 1/3 jego szerokości (Pagliara i Kurdistani 2016). Główną konstrukcję stanowiły paliki drewniane zabite w dno strumienia o długości 1,20–1,50 m i średnicy 0,04 m, oddalone od siebie o 0,40 m. Pomiędzy nimi przepleciono lokalnie pozyskaną wiklinę, która stanowiła wypełnienie przestrzeni pomiędzy palikami deflektora oraz pozwalała odkształcić linię nurtu od osi cieku. Każdy z deflektorów został usytuowany współprzeciwko pod kątem 70–80° do linii nurtu (Ryc. 2). Kąt ten w początkowym etapie renaturyzacji zapewnia skuteczniejsze odkształcenie linii nurtu i rozpoczęcie procesu meandrowania. Wybór lokalizacji deflektorów został podjęty w oparciu o analizę charakteru odcinka badawczego. Silne przekształcenia hydromorfologiczne i prostoliniowy ujściowy fragment Flinty został już dobrze rozpoznany w latach 2005–2017.

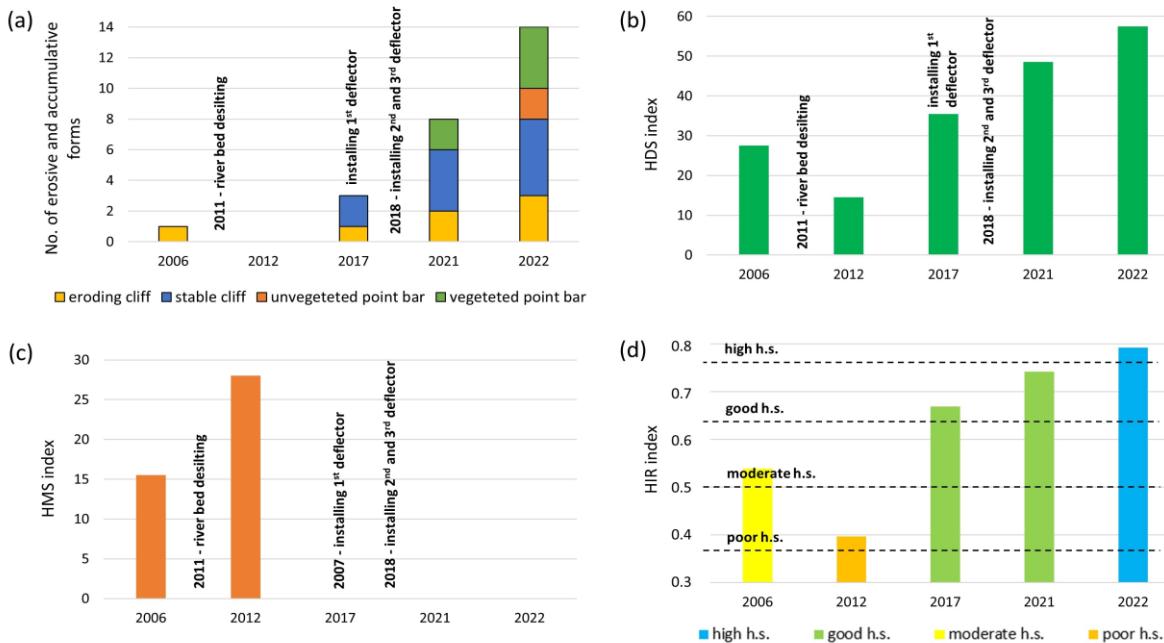
Ryc. 3. Zmiennosć czasowa wybranych parametrów hydromorfologicznych na odcinku badawczym z deflektorami: (a) liczba form erozyjnych i akumulacyjnych; (b) wskaźnik HDS; (c) wskaźnik HMS; (d) wskaźnik HIR; h.s.– stan hydromorfologiczny (Zaborowski i in. 2023a)

Ryc. 3a. Ostatecznie bardzo dobry stan hydromorfologiczny udało się osiągnąć po 4 latach od wprowadzenia grupy deflektorów (Ryc. 3d).

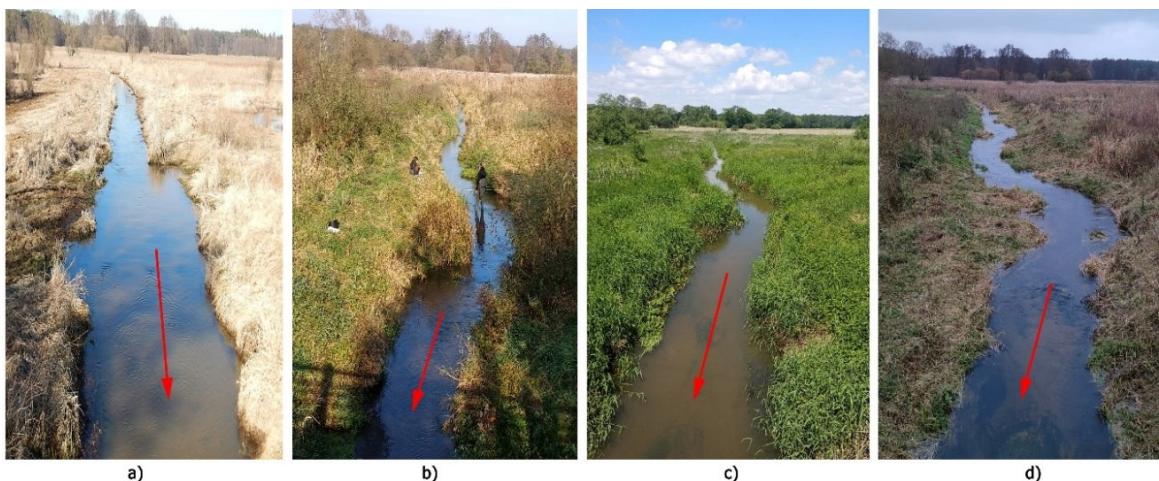
Ryc. 4. Zmiany koryta rzeki Flinty na badanym odcinku w latach 2013–2023. Terminy wykonania zdjęć: a) marzec 2013 r., b) październik 2019 r., czerwiec 2021 r., listopad 2023 r. (Zaborowski i in. 2024)

Dokumentacja fotograficzna [I i IV] potwierdza, że intensyfikacja procesów renaturyzacyjnych na odcinku badawczym B (z deflektorami) nastąpiła dopiero po wprowadzeniu deflektorów (Ryc. 4). Obserwacje te pozwalają potwierdzać możliwość wykorzystania prostych i tanich w wykonaniu budowli seminaturalnych do inicjacji i intensyfikacji procesu zwiększenia krętości koryta (meandrowania) w niewielkich i przekształconych ciekach nizinnych w całej Polsce.

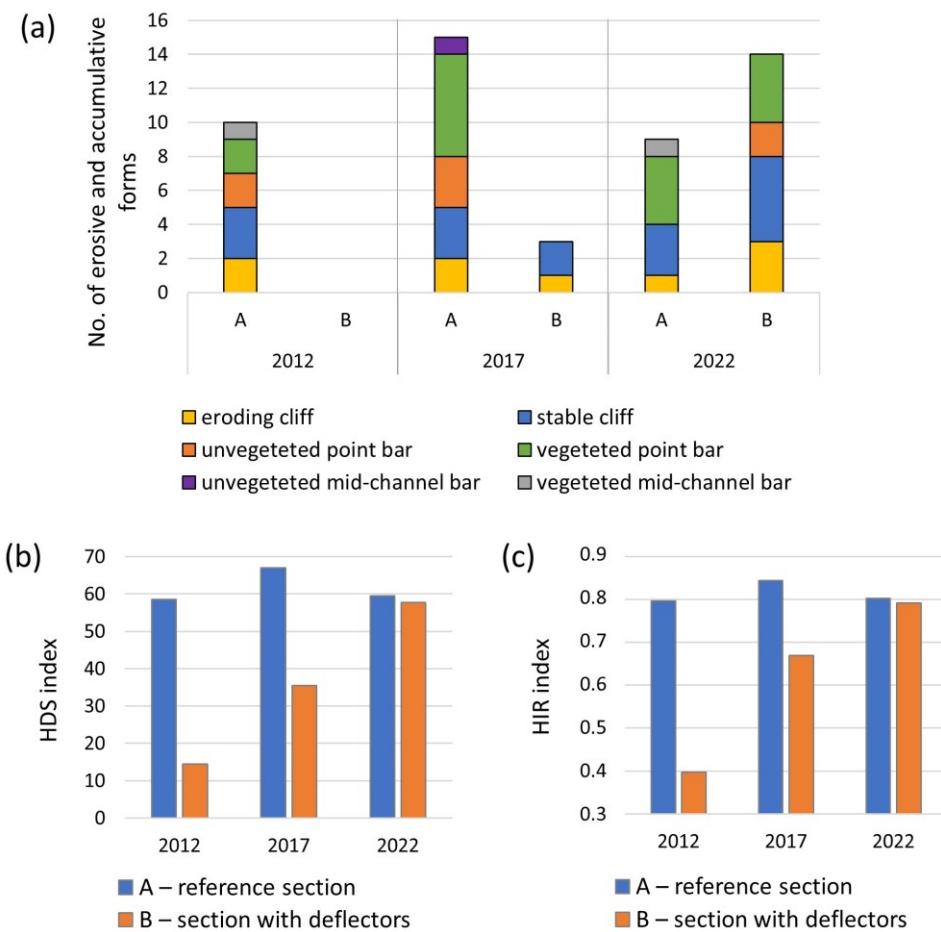
Ryc. 5. Porównanie zmienności w czasie wybranych parametrów hydromorfologicznych pomiędzy odcinkiem z deflektorami (B) a odcinkiem porównawczym (A): (a) liczba form erozyjnych i akumulacyjnych; (b) wskaźnik HDS; (c) wskaźnik HIR

Zarówno badania metodą HIR jak i klasyfikacja stanu hydromorfologicznego [III] pozwoliły określić zmiany jakie miały miejsce na odcinku z deflektorami (B) i porównać je z seminaturalnym odcinkiem porównawczym (A). Widoczny na rycinie (Ryc. 5a) nagły przyrost liczby naturalnych form morfologicznych w korycie od momentu wprowadzenia deflektorów świadczy o intensyfikacji procesów hydromorfologicznych. Analogiczną zależność obserwujemy w przypadku wskaźników HIR i HDS (Ryc. 5b i c), co potwierdza wzrost heterogeniczności koryta na odcinku rzeki poddanym indukowanej renaturyzacji (B). Świadczy to o pozytywnym wpływie deflektorów na dynamikę zachodzących procesów hydromorfologicznych.

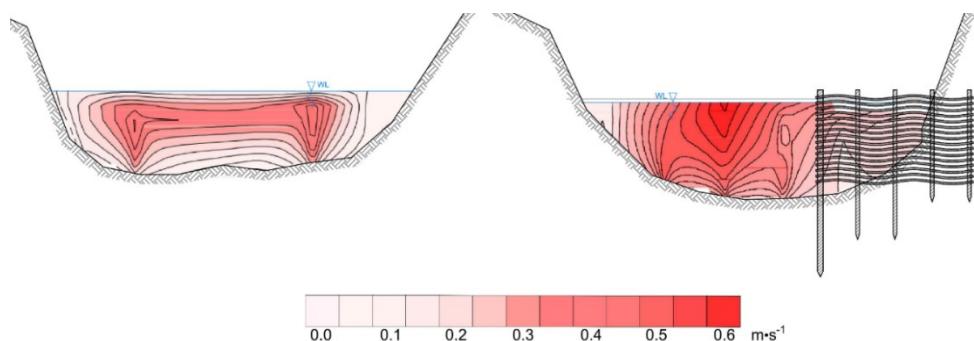
Ryc. 6. Zmiany rozkładu prędkości przed i po wprowadzeniu deflekторa do rzeki

Deflektory wpływają na zróżnicowanie rozkładu prędkości w przekroju i w bezpośrednim jego sąsiedztwie (Ryc. 6) [I]. W przekroju deflekatora obserwowana jest koncentracja przepływu, a co za tym idzie lokalny wzrost prędkości. W aspekcie globalnym deflektory silnie wpływają na rozkład prędkości i naprężeń stycznych na całym odcinku. Początkowo powstają strefy większych prędkości, zlokalizowane przy główkach samych deflektorów, a z czasem wykształca się kręta (sinusoidalna) linia nurtu (Ryc. 7).

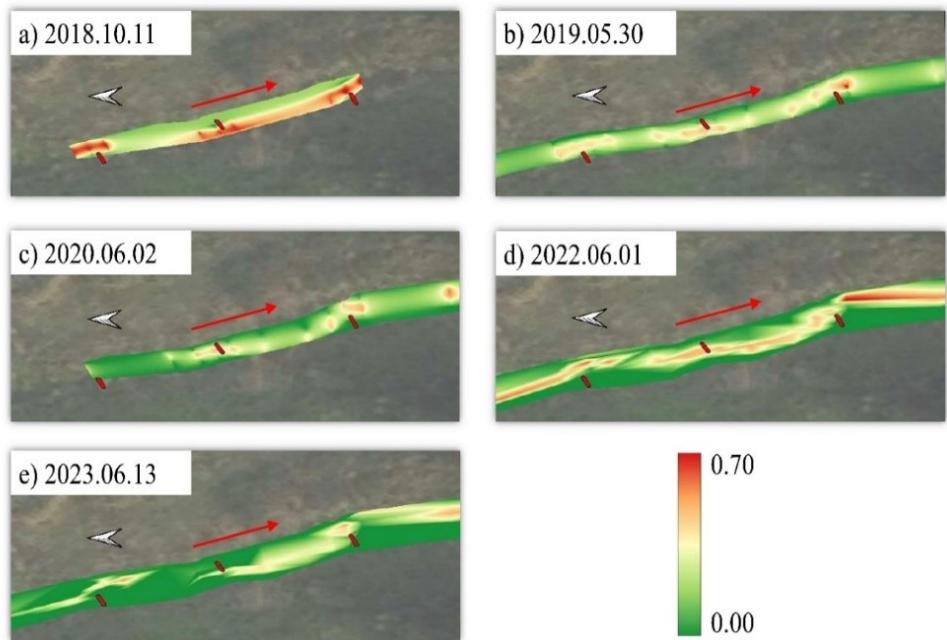
Ryc. 7. Zmiany rozkładu średnich prędkości ($\text{m}^3 \cdot \text{s}^{-1}$) w planie po wprowadzeniu deflekторów

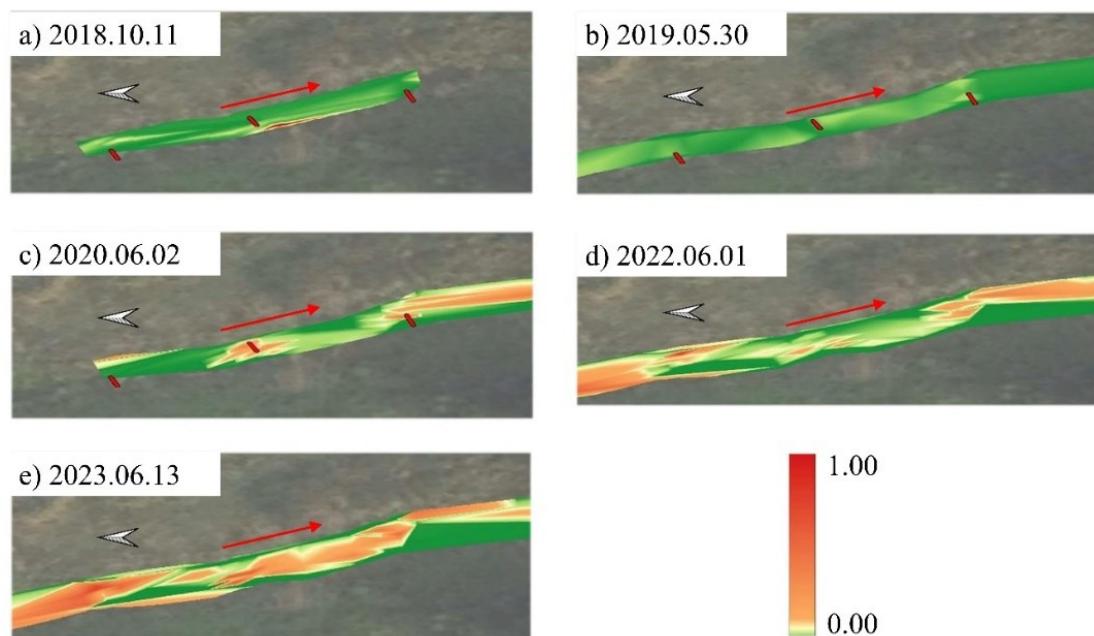
Ryc. 8. Zmiany naprężen stycznych w korycie dla przepływów $0.200 \text{ m}^3 \cdot \text{s}^{-1} \pm 10\%$ w latach 2018–2023 (wartości w $\text{N} \cdot \text{m}^{-2}$)

Na podstawie danych pomiarowych obliczono naprężenia styczne w korycie [IV]. Przypisanie danych przestrzennych wartościom naprężen stycznych w poszczególnych pionach pozwoliło na wygenerowanie rycin z rozkładami naprężen (Ryc. 8). Analiza danych wykazała sukcesywny wzrost wartości naprężen stycznych w czasie. Największe wartości naprężen występują w linii nurtu w pobliżu deflektorów na brzegach wklęsłych. Poniżej deflektorów w ich cieniu hydrodynamicznym naprężenia styczne są zauważalnie mniejsze.

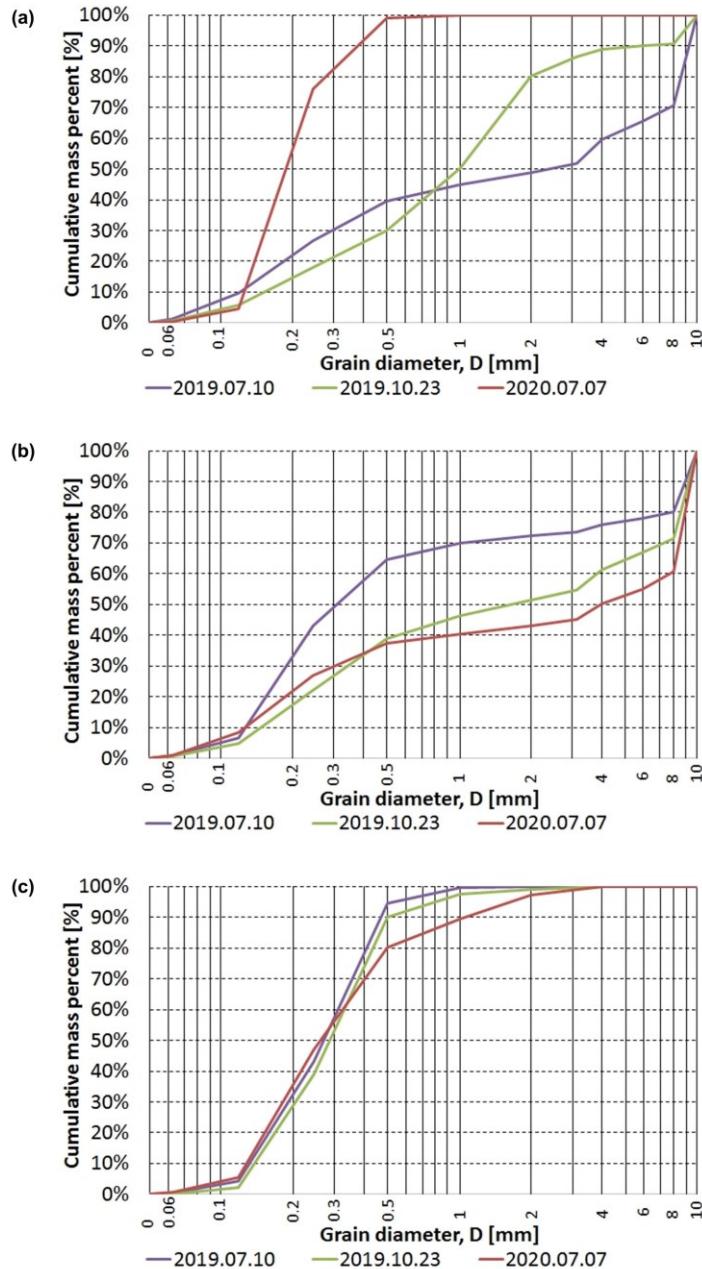
Ryc. 9. Zmiany składu granulometrycznego rumowiska w: (a) przekroju 1 m poniżej deflektora (w cieniu deflektora), (b) w linii nurtu w przekroju 2 m poniżej deflektora, (c) w profilu nr 27 powyżej zasięgu oddziaływanego deflektorów

Potwierdzeniem powstania zróżnicowanych warunków mikrosiedliskowych w korycie są wyniki analizy składu rumowiska w założonych punktach poboru [I–IV]. W pobliżu deflektorów w linii nurtu dochodziło do silnego przesortowania materiału dennego, lokalnie tworząc obrukowanie dna oraz odsypiska. W bezpośrednim sąsiedztwie deflektora obecne były strefy z dominującą frakcją żwirową (Ryc. 9b). W okresie zaledwie jednego roku (2019–2020) zaobserwowano wzrost uziarnienia frakcji d_{50} z 0,3 mm do 4,0 mm wzdłuż linii nurtu. Poniżej deflektora w strefie osłoniętej przez jego konstrukcję dochodziło do akumulacji frakcji drobnoziarnistych. Obszar ten został utrwalony przez jeżogłówkę gałęzistą (*Sparganium erectum*), zmniejszając średnicę cząstek frakcji $d_{50\%}$ z 2,50 mm do 0,18 mm. Wzrost heterogeniczności składu rumowiska dna zapewnia zróżnicowane warunki do bytowania gatunkom makrofitów i makrobezkregowców o różnych preferencjach siedliskowych (Szałkiewicz i in. 2022).

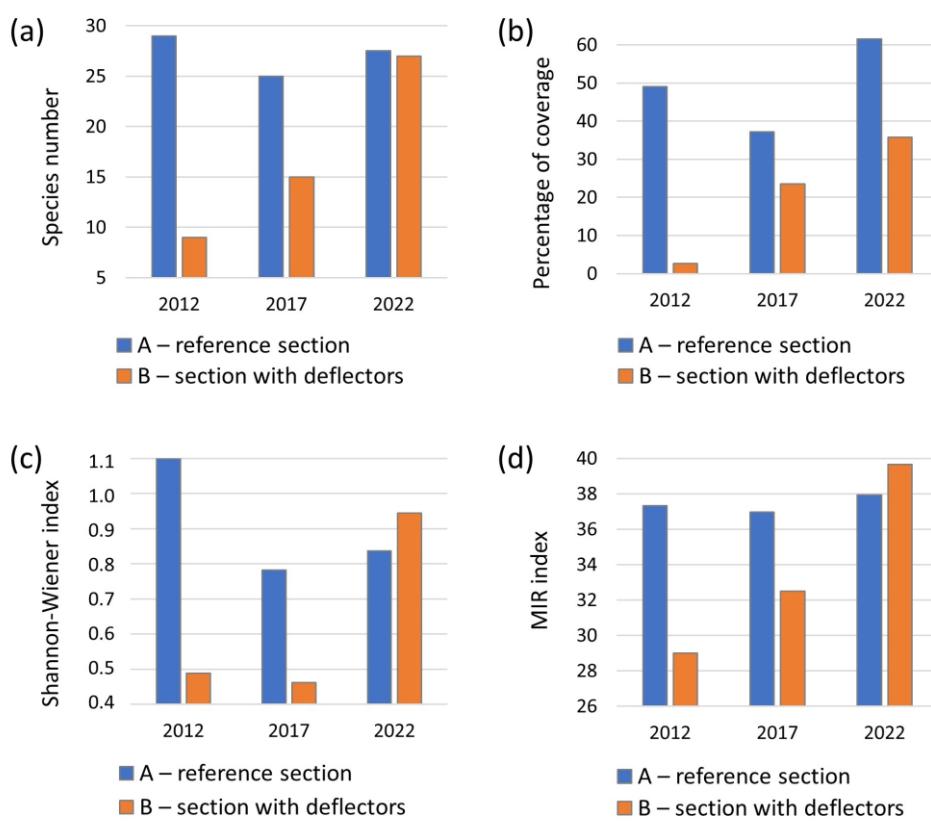
Ryc. 10. Porównanie zmienności w czasie wybranych parametrów makrofitowych pomiędzy odcinkiem z deflektorami (B) a odcinkiem porównawczym (A): (a) liczba taksonów; (b) procent pokrycia dna roślinnością; (c) wskaźnik bioróżnorodności Shannona–Wienera; (d) Makrofitowy Indeks Rzeczny (MIR)

Na rycinie (Ryc. 10a) widoczny jest pozytywny wpływ wprowadzenia deflektorów na przyrost liczby gatunków makrofitów. Początkowo (w latach 2012–2017) obserwowany jest powolny powrót kolejnych gatunków oraz dwukrotnie szybszy przyrost po wprowadzeniu deflektorów, aż do osiągnięcia liczby gatunków występujących na odcinku seminaturalnym (w 2022 roku). Świadczy to o odtworzeniu korzystnych warunków bytowania wszystkich występujących w dolnej rzece Flincie makrofitów. Poza wzrostem pokrycia koryta przez roślinność z 23 do 35% widoczny jest również znaczny wzrost wskaźnika bioróżnorodności z 0,5 do 0,95 (Ryc. 10c). Świadczy to o bardzo korzystnym wpływie deflektorów na wzrost zróżnicowania mikro- i mezosiedlisk. Widoczna jest również sukcesywna poprawa stanu ekologicznego mierzonego wskaźnikiem MIR na odcinku renaturyzowanym względem stabilnej sytuacji na odcinku seminaturalnym (Ryc. 10d). Porównując obydwa odcinki rzeki należy stwierdzić, analogicznie jak w przypadku warunków hydromorfologicznych, że w obrębie odcinka z deflektorami obserwujemy stopniową poprawę stanu ekologicznego. Najpierw spontaniczną, a od 2017 roku indukowaną oddziaływaniami deflektorów. W wielu przypadkach udało się uzyskać parametry odpowiadające odcinkowi nieprzekształconemu (Ryc. 10a, c i d).

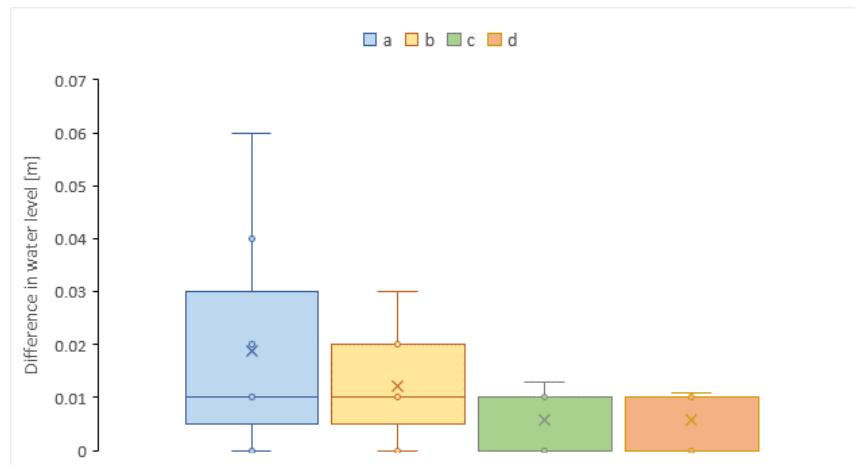
Ryc. 11. Średnie i maksymalne różnice między modelem HEC–RAS a pomiarami terenowymi ZW.

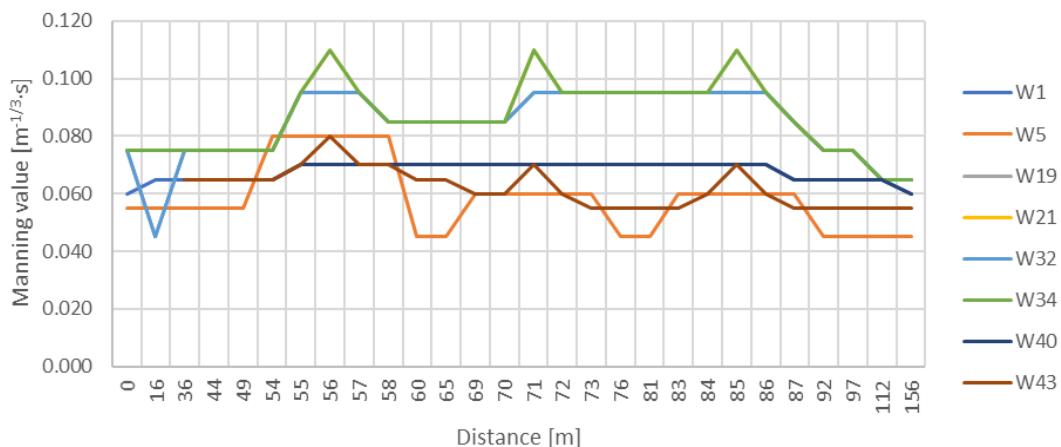
Ryc. 12. Zmiany średniego współczynnika Manninga dla poszczególnych przekrojów pomiarowych i wybranych wariantów

Na rycinie przedstawiono przebieg zmian uśrednionych wartości współczynników Manninga dla poszczególnych przekrojów oraz wybranych wariantów (Ryc. 12). W zależności od sposobu implementacji deflektorów w modelu oraz warunków przepływu współczynniki Manninga kształtuje się na różnym poziomie. Jednak widoczny jest ich lokalny wzrost w pobliżu deflektorów.

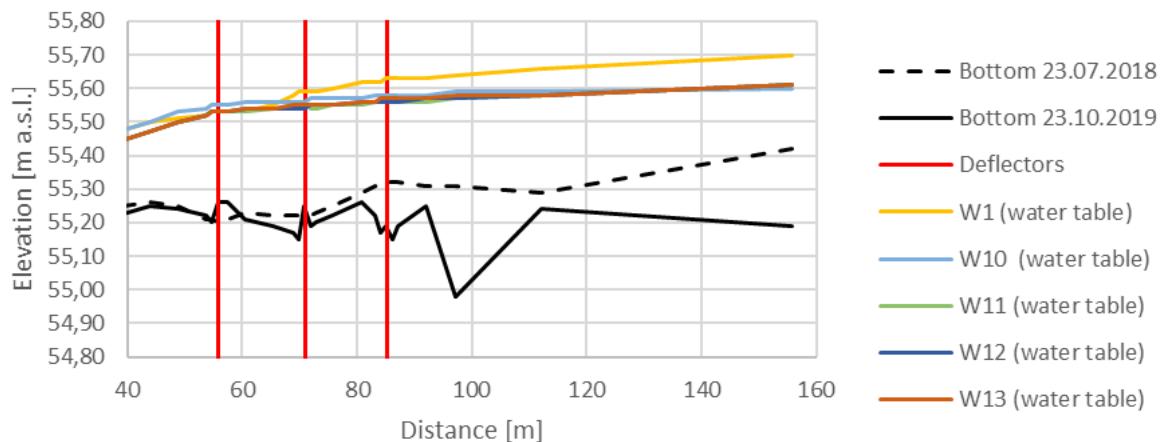
Ryc. 13. Porównanie zmian poziomu ZW dla $Q = 0,200 \text{ m}^3 \cdot \text{s}^{-1}$ przed wprowadzeniem deflektorów (W1) oraz po ich implementacji (W10–13)

określić układ zwierciadła wody dla wykorzystywanych parametrów modelu matematycznego i przepływów, m.in. $Q = 0,200 \text{ m}^3 \cdot \text{s}^{-1}$ oraz $Q_{1\%}$. W rzece Flincie największy wpływ deflektorów był obserwowany podczas przepływów niskich, gdzie w warunkach naturalnych strumień nie ma wystarczającej energii do inicjacji procesów korytotwórczych. Uzyskane różnice w układzie zwierciadła wody dochodziły do 0,04 m (Ryc. 13). Wraz ze wzrostem przepływów, a tym samym napełnienia koryta (w szczególności po wystąpieniu wody z brzegów), wpływ deflektorów zanika. Ich oddziaływanie traci na znaczeniu już podczas przepływów większych niż średnie. Świadczą o tym przeprowadzone symulacje dla przepływu o prawdopodobieństwie wystąpienia 1%, co odpowiada $11,97 \text{ m}^3 \cdot \text{s}^{-1}$. Porównując wyniki dla modelu bez deflektorów (W40) z pozostałymi wariantami (W41–44) stwierdzono, że różnice te wynoszą 0,00–0,02 m (Ryc. 14). W warunkach przepływów średnich i wód wielkich wpływ deflektorów jest więc pomijalny.

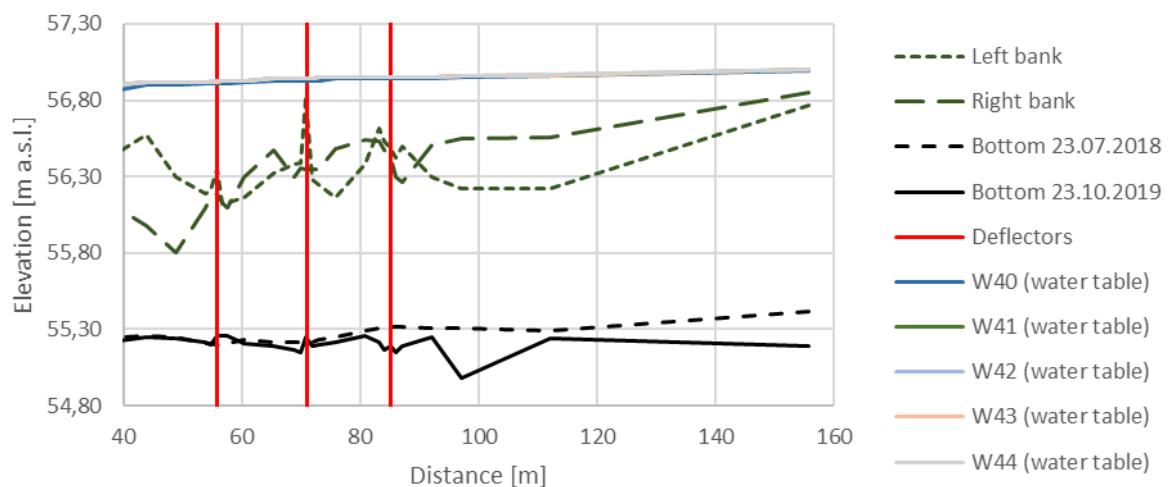
Ryc. 14. Porównanie zmian poziomu ZW dla $Q_{1\%}$ w wariantach W40–W44 (po wprowadzeniu deflektorów) w rzece Flincie

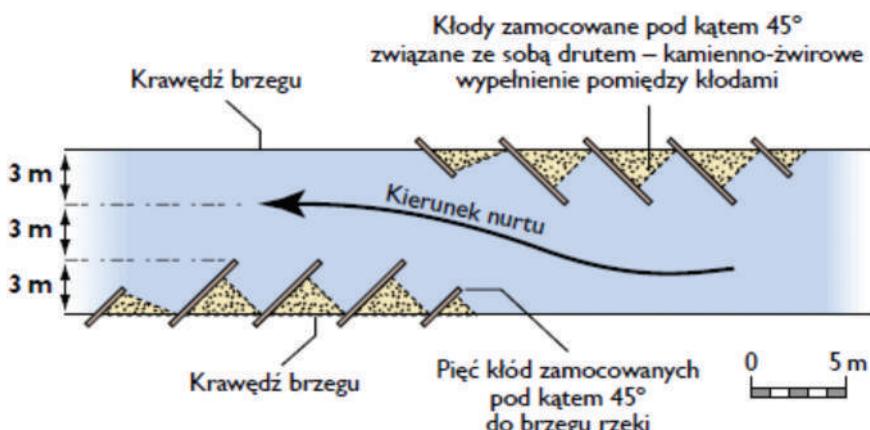
Ryc. 1. Szkic sytuacyjny deflektorów wykonanych w postaci kłów drewna zamocowanych pod kątem 45° z wypełnieniem kamiенно-żwirowym pomiędzy kłodami

W podręczniku Manual of River Restoration Techniques (Polska Zielona Sieć 2006) podano przykład przebudowy prostych odcinków koryta za pomocą deflektorów zrealizowany na rzece Skerne w Darlington, hrabstwo Durham (ryc. 1). Ponieważ dotychczas na wyprostowanym odcinku rzeki nie występowały procesy akumulacji postanowiono „wymusić” warunki, które spowodowałyby zarówno podmywanie, jak i odkładanie osadów. Uzyskano to dzięki serii deflektorów, o różnej długości, wystających ponad poziom wody. Przyspieszyły one przepływ wody w strefie nurtu, powodując podmywanie u ich wierzchołków, z równoczesnym tworzeniem zawirowań, które ułatwiały akumulację wzdłuż brzegu. Proces odkładania niesionych prądem osadów przyspieszono, wbudowując w deflektory kamienie i glinę, tak aby zainicjować tworzenie wypłyceń.

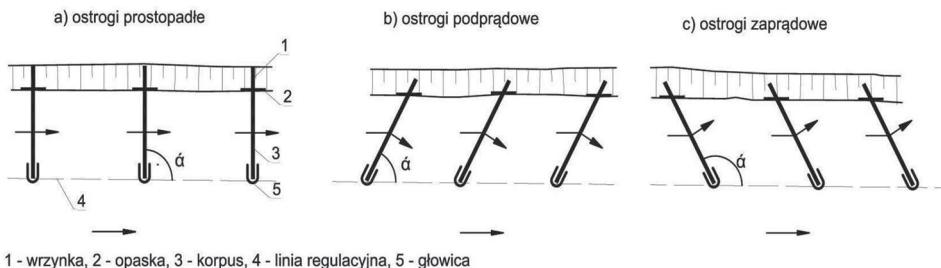
Ryc. 2. Rodzaje usytuowania ostróg/deflekторów w zależności od ich kierunku względem nurtu rzeki (Wołoszyn 1994)

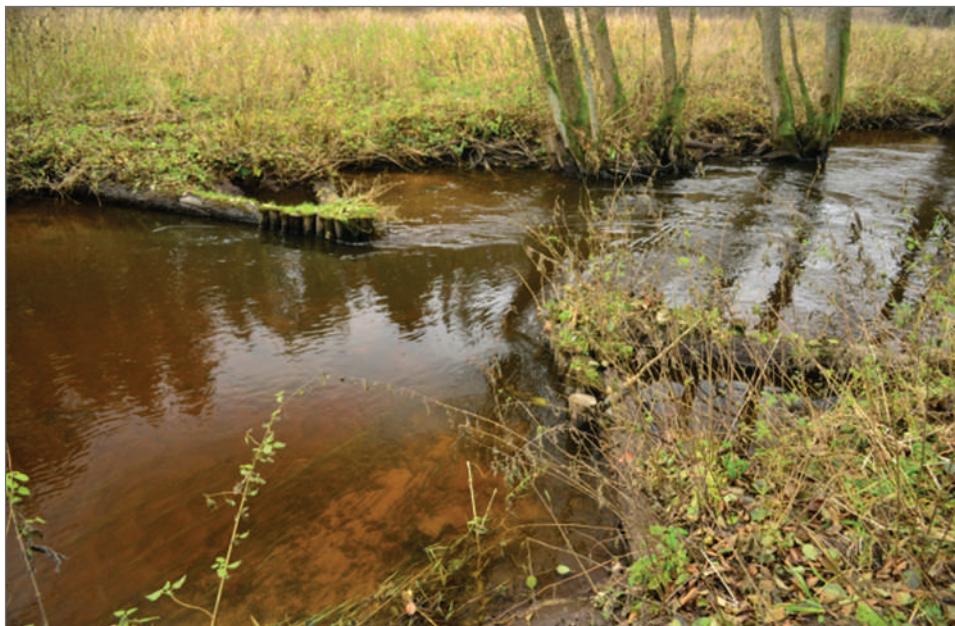
Ryc. 3. Przykład wykonanych deflekторów drewnianych zrealizowanych w ramach renaturyzacji rzeki Kwaczki (Waradzin 2016)

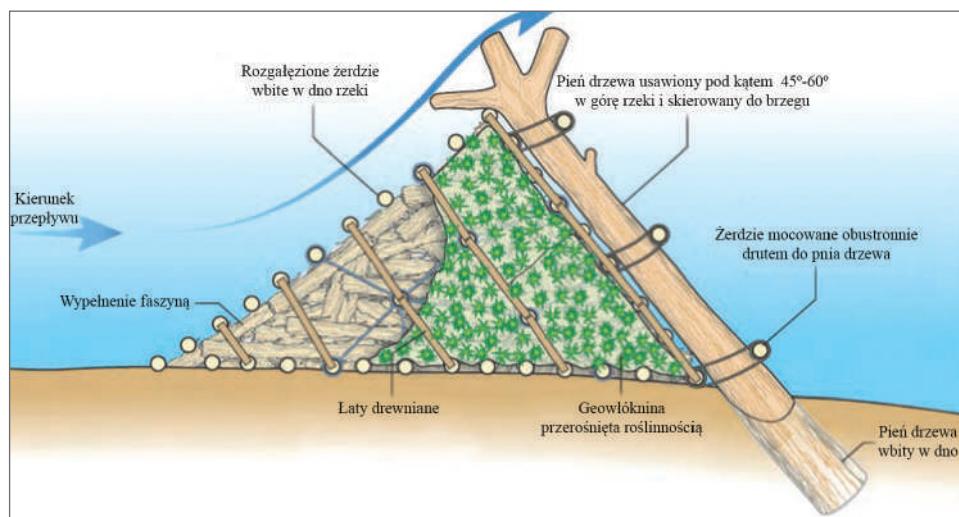
Ryc. 4. Deflektory z kłów drewna jako element umocnień „żęby smocze” (Stream 2009)

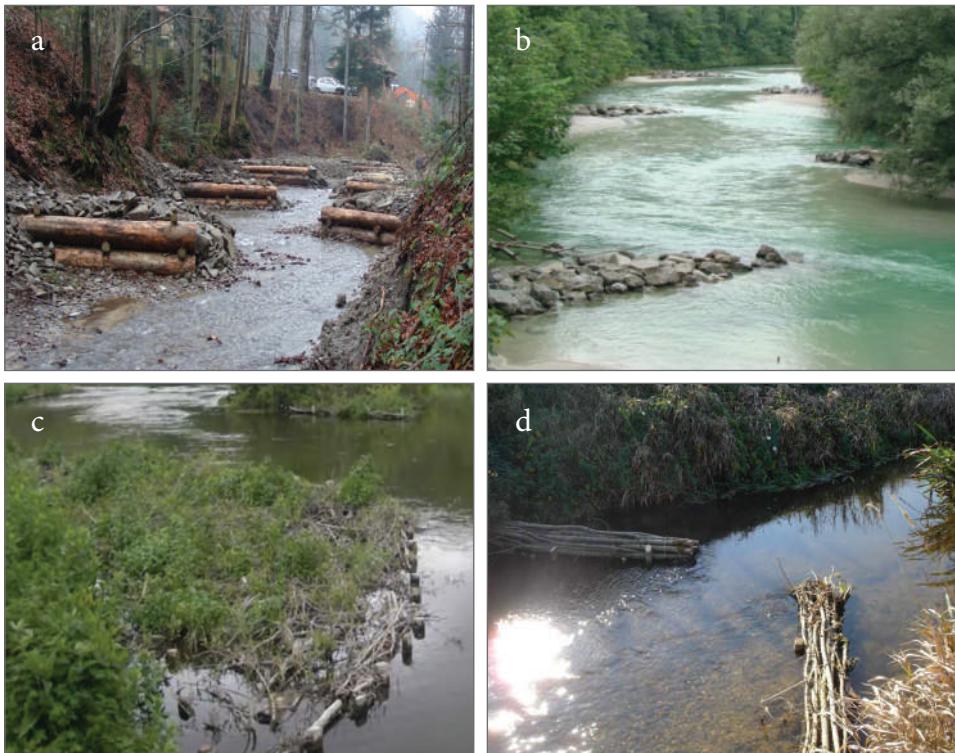
Ryc. 5. Przykłady różnych rozwiązań konstrukcyjnych deflektorów, a) zabudowa deflektorami z kłów drewnianych i narzutu kamiennego koryta potoku górskego Roztoka Mała (PGW 2018), b) system deflektorów kamiennych na rzece górskiej Königsseer Ache, Austria (Radzicki 2016), c) deflektor wiklinowy w kształcie litery D na rzece nizinnej Skerne UK (Stream 2009), d) deflektor z kiszki faszyzowej – rzeka nizinna Welland UK (Ecologylink 2020)

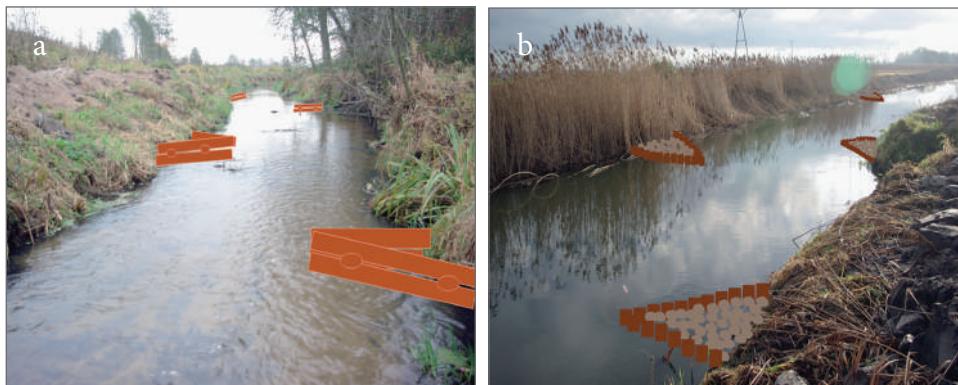
Ryc. 7. Propozycja usytuowania deflektorów drewnianych na Flincie, stanowisko Ninino oraz deflektorów drewniano-kamiennych na Wełnie w Rogoźnie (Szoszkiewicz i in. 2014)

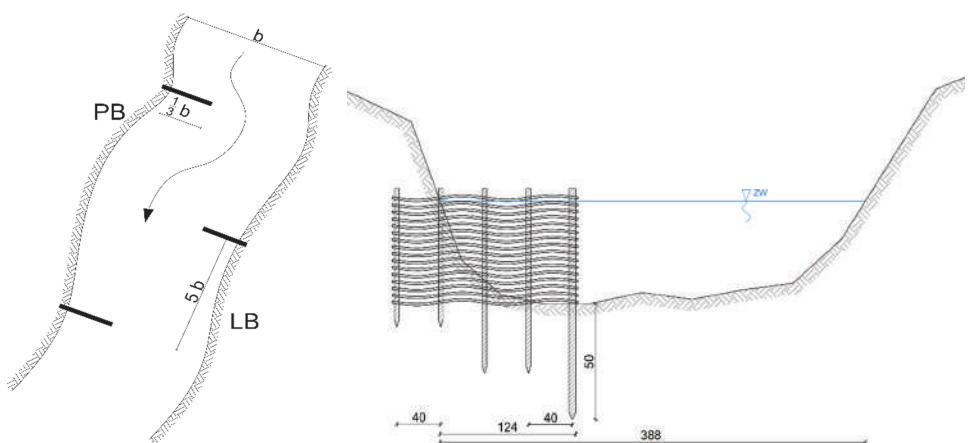
Ryc. 8. Schemat deflektora i układ rozmieszczenia deflektorów na badanym odcinku Flinty

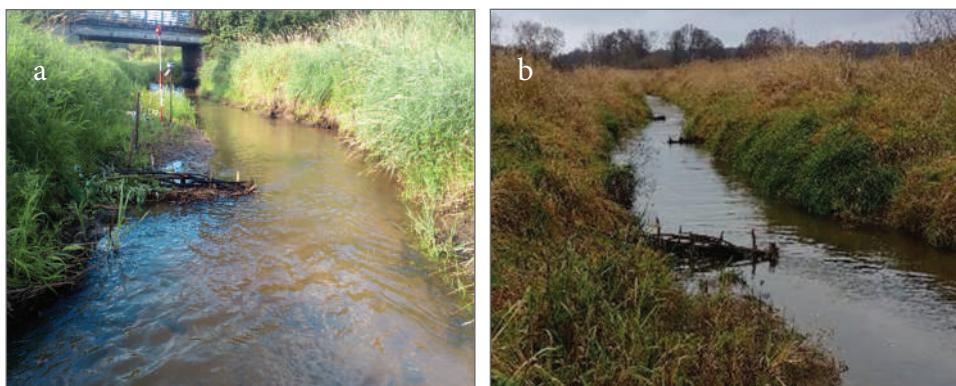
Ryc. 9. Usytuowanie deflektorów wiklinowych na badanym odcinku rzeki Flinty; fot. Autorów

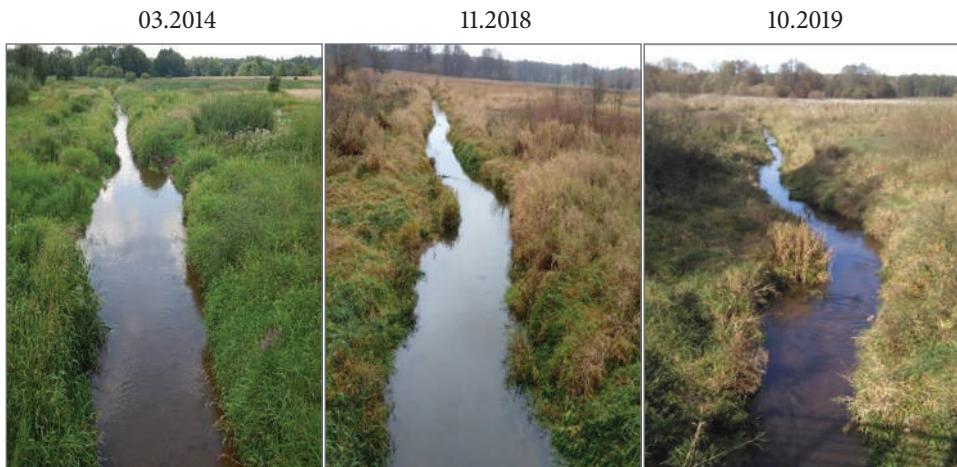
Ryc. 10. Zmiany biegu rzeki Flinty po wybudowaniu deflektorów wiklinowych: a) 2014 – sytuacja przed wybudowaniem, b) 2018 w roku zainstalowania deflektorów i c) sytuacja po rocznym oddziaływaniu konstrukcji; fot. Autorów

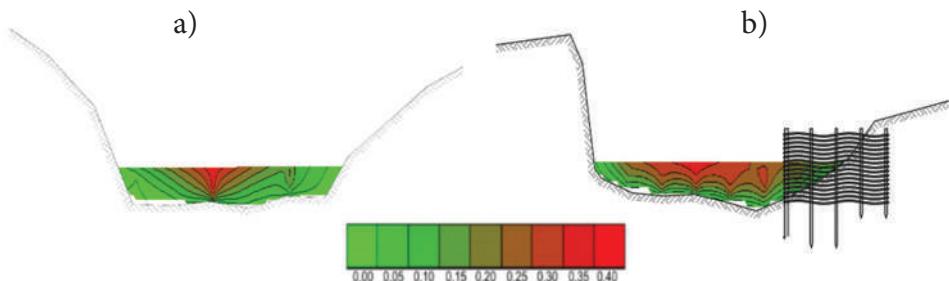
Ryc. 11. Porównanie schematu rozkładu prędkości dla przekroju poprzecznego nr 14. Rozkłady prędkości przed budową deflektorów (23.07.2018) (a) oraz po wybudowaniu deflektorów (14.03.2019) (b)

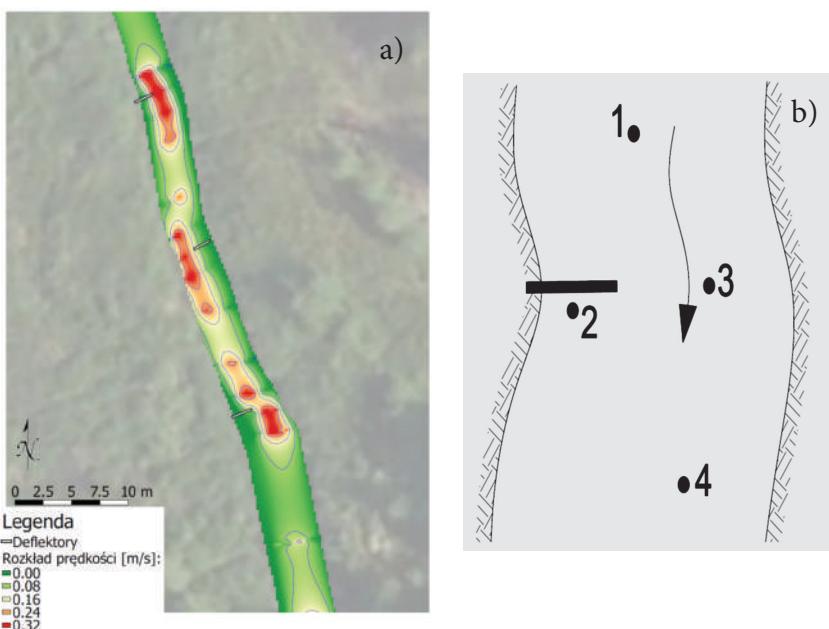
Ryc. 12. Zmiany rozkładów prędkości w pobliżu deflektorów na podstawie pomiarów 10.07.2019 (a) oraz schemat położenia punktów poboru rumowiska (b)

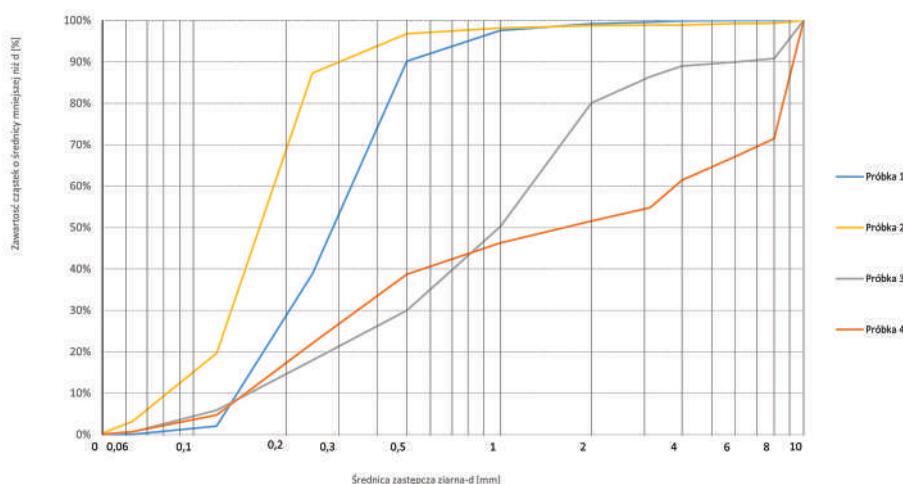
Ryc. 13. Krzywa uziarnienia dla czterech punktów poboru próbek gruntu (23.10.2019)

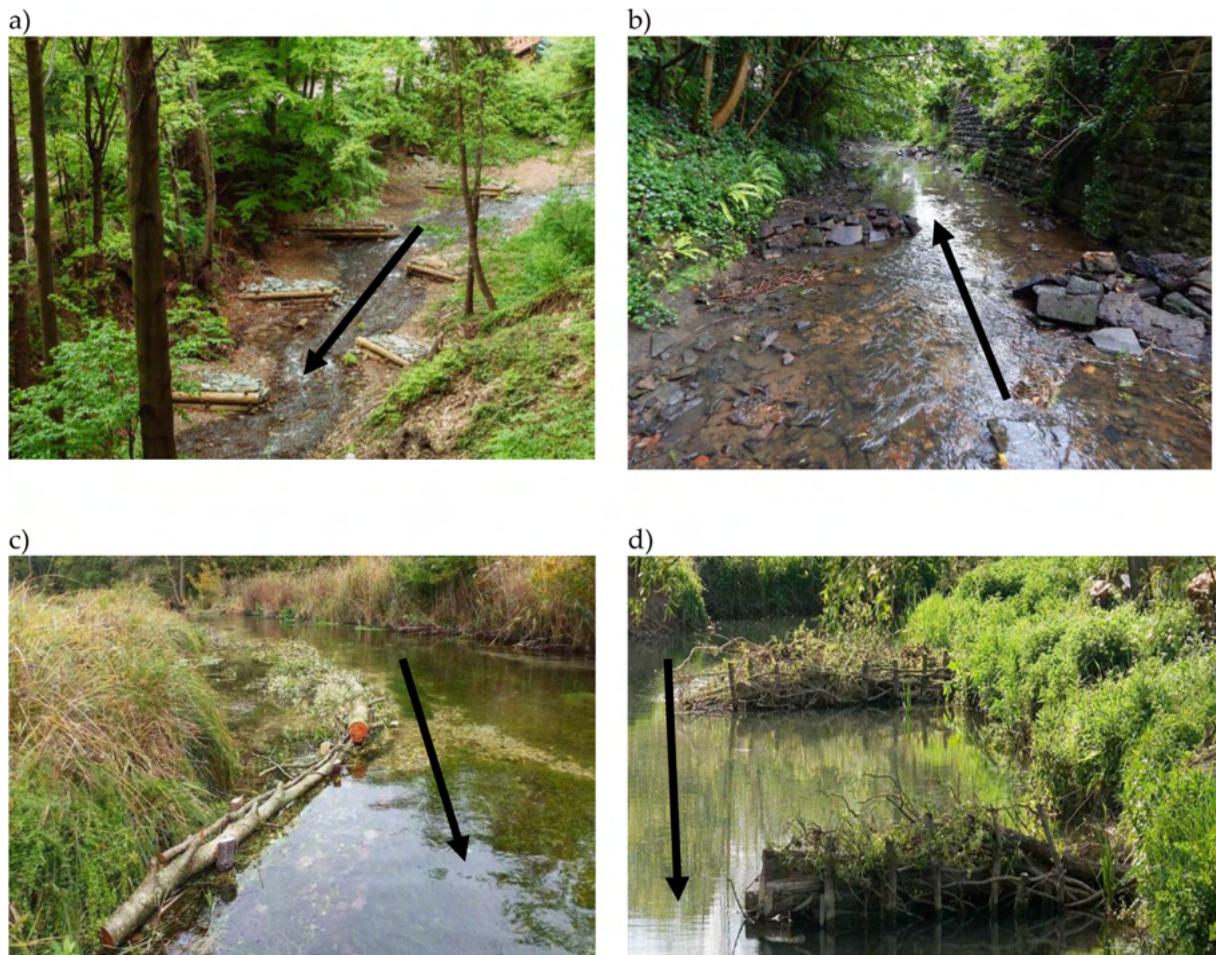
Fig. 1. Examples of different deflector design solutions, a) deflector development with logs and stone erratics of the Roztoka Mała mountain stream bed ([PGW, 2018](#)), b) stone deflector system on the Königsee Ache mountain river, Austria ([rivercale.org, 2021](#)), c) D-shaped wicker deflector on the lowland river Skerne, UK ([wildtrout.org, 2021](#)), d) fascine silage deflector – the lowland river Welland UK ([bristolavonrivertrust.org, 2021](#))

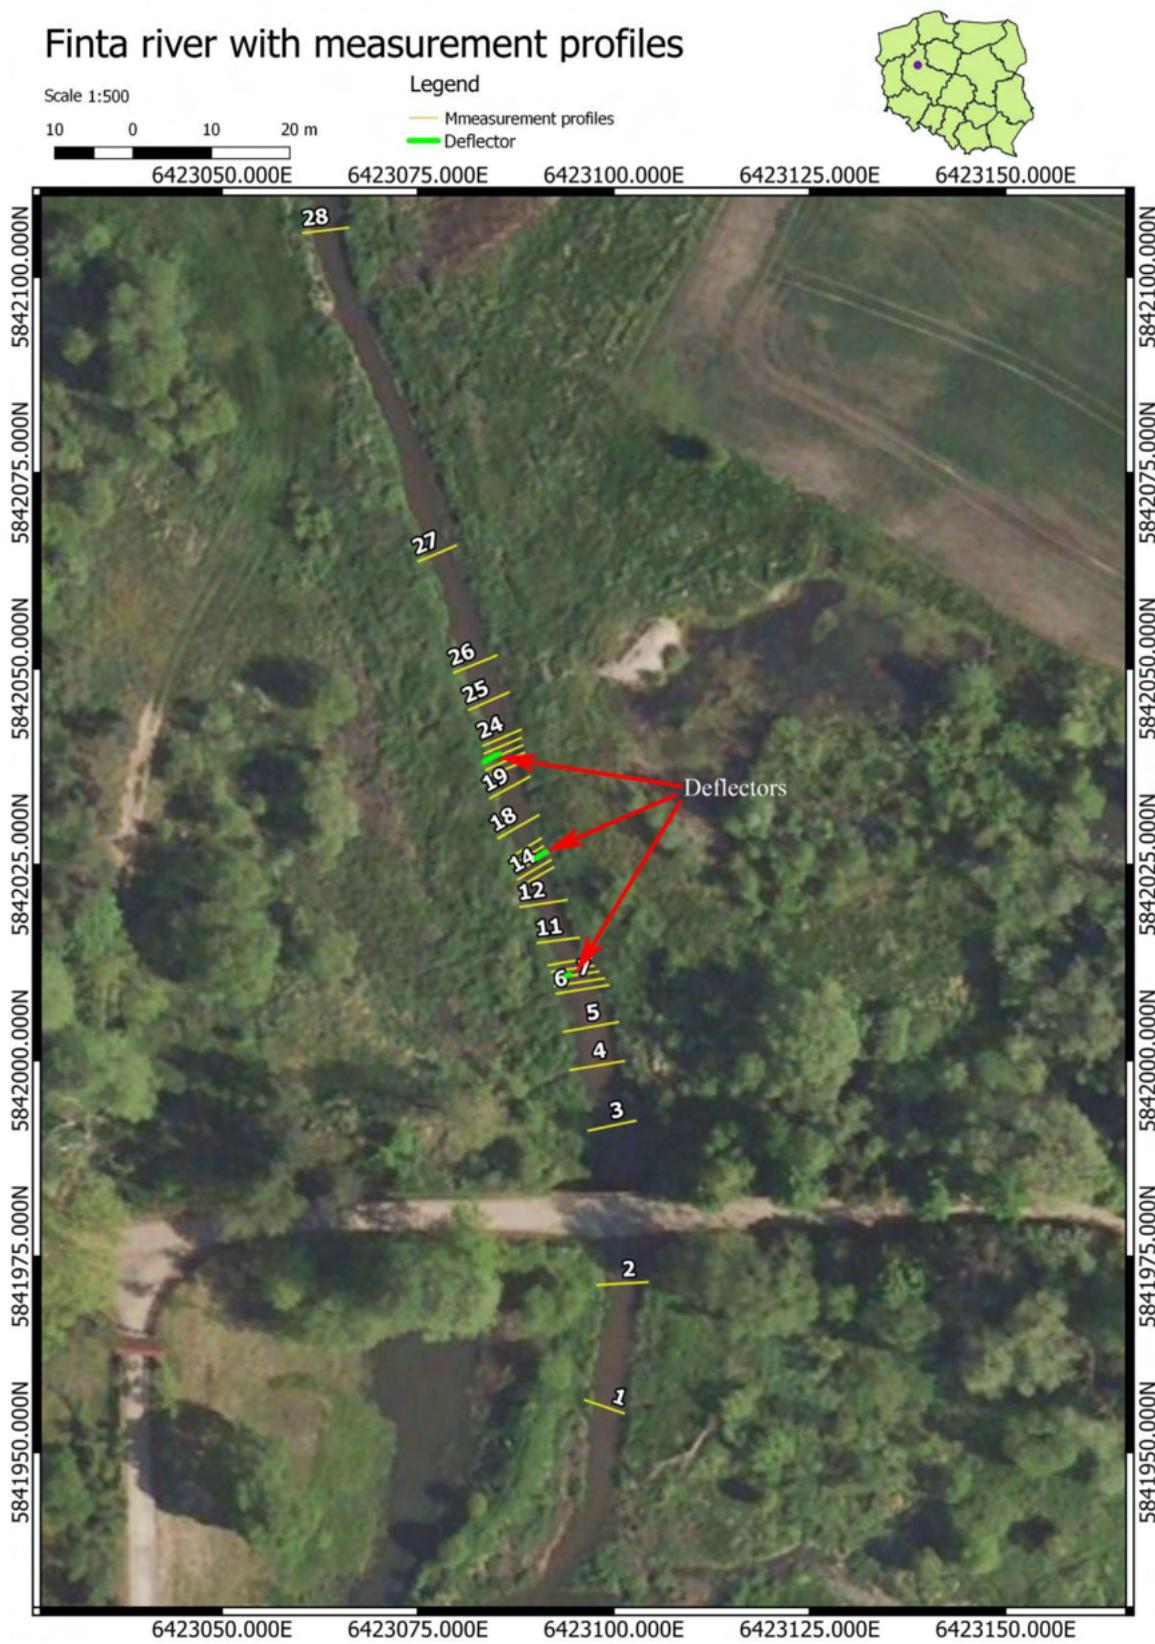
Fig. 3. Map of the Flinta river study section with research cross-sections. and location of deflectors.

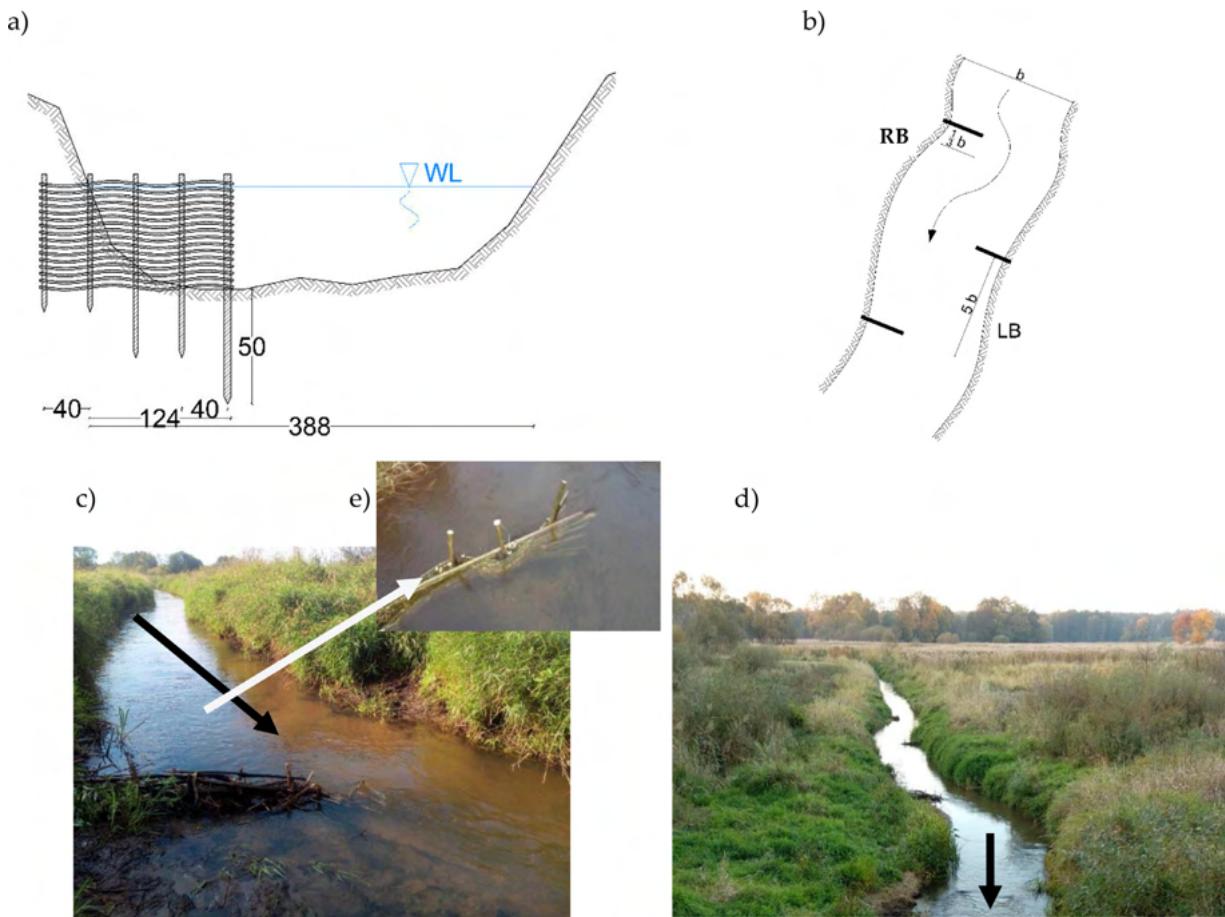
Fig. 4. The deflector scheme and placement along the studied section of the Flinta river: a) scheme of deflector structure; b) scheme of the location of deflectors in the river; c) completed deflector in the river; d) the Flinta river with completed deflectors; e) wicker deflector.

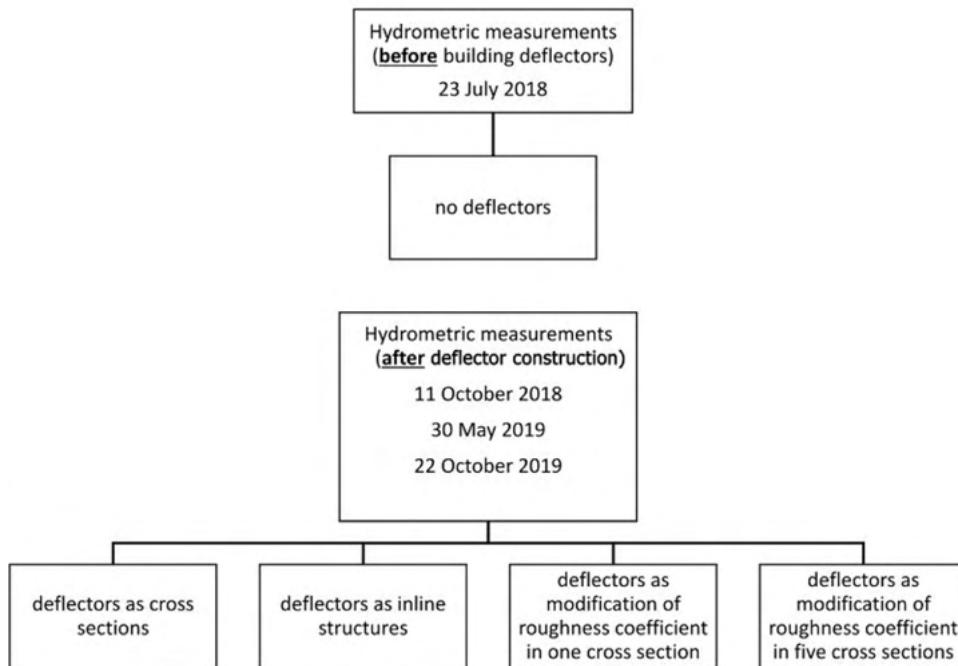
**Fig. 5.** A scheme of the hydrodynamic models

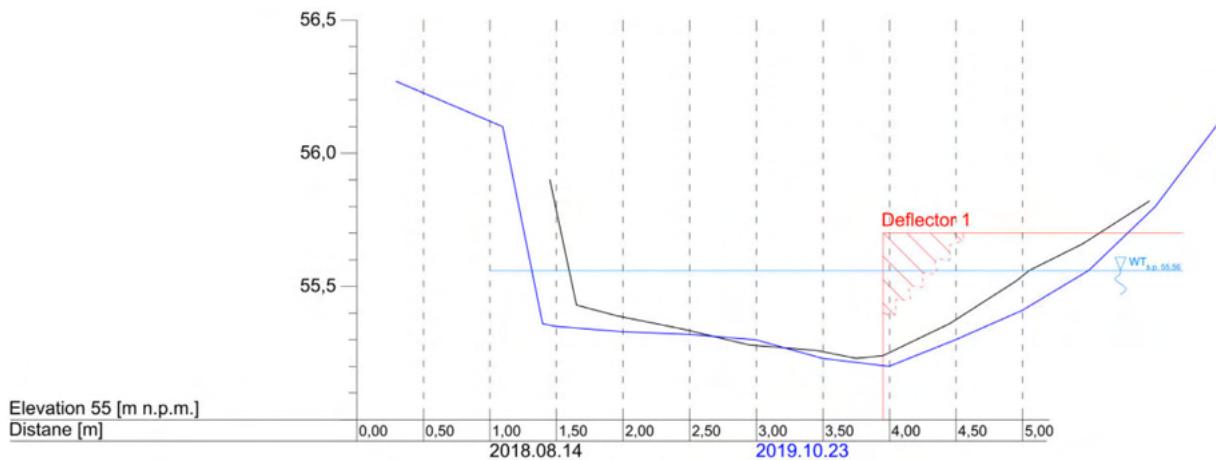
Fig. 6. Changes in the layout of the riverbed.
