Wpływ deflektorów na warunki hydromorfologiczne panujące w małej rzece nizinnej na przykładzie rzeki Flinty

Impact of deflectors on hydromorphological conditions prevailing in a small lowland river on the case of the Flinta River

Rozprawa doktorska w dziedzinie nauk inżynierijno–technicznych
w dyscyplinie inżynieria, górnictwo i energetyka
Doctoral thesis in engineering and technology sciences
in the environmental engineering, mining and energy discipline

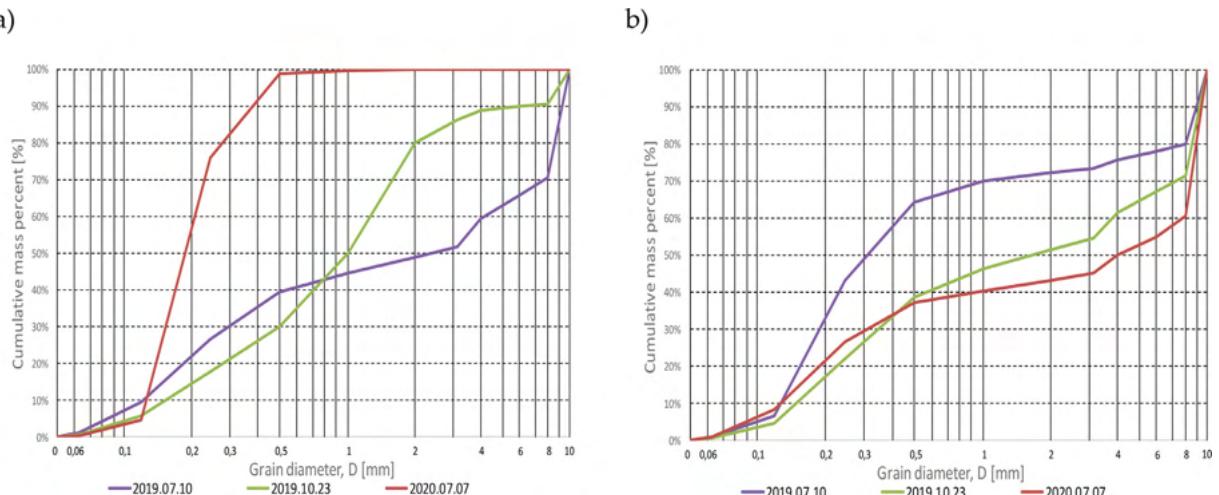
Fig. 7. Changes in sediment size, a)- upstream of the deflector cross-section; b)- cross-section downstream of deflector.

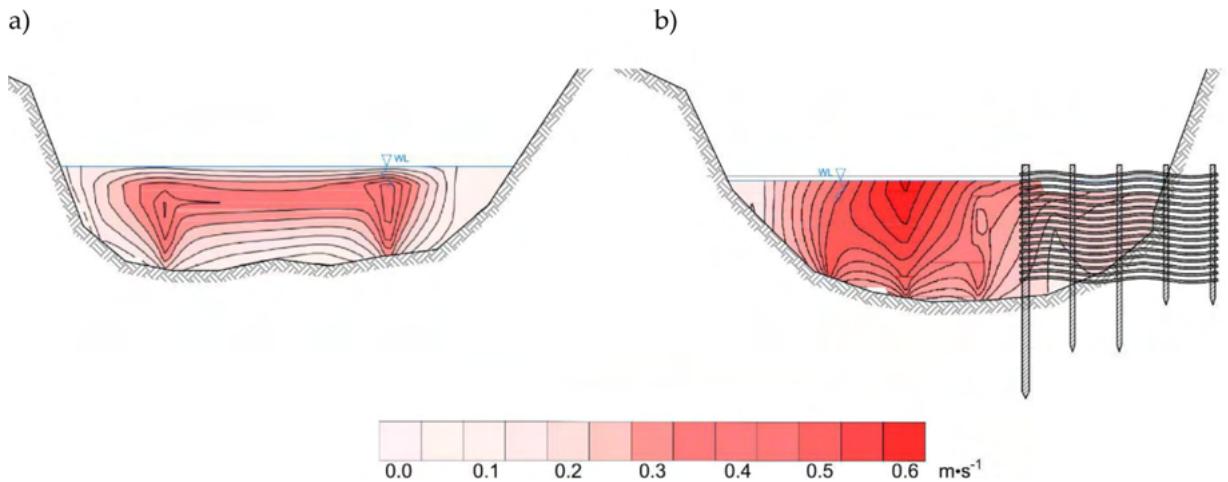
Fig. 8. Comparison of the water velocity distribution pattern for the Flinta river cross-section no. 22. Velocity values on 23/07/2018 (a) before deflector construction (Before DC) and 23/10/2019 (b) after deflector construction (After DC).

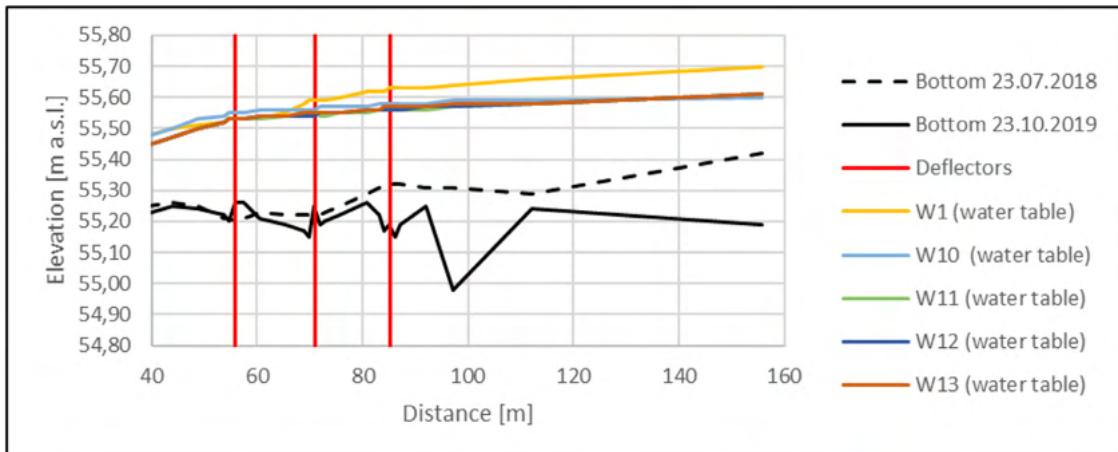
Fig. 9. Comparison of water surface profile for $0.200\text{m}^3/\text{s}$ flow for W1 (Before DC), W10-W13 (After DC): on the Flinta river.

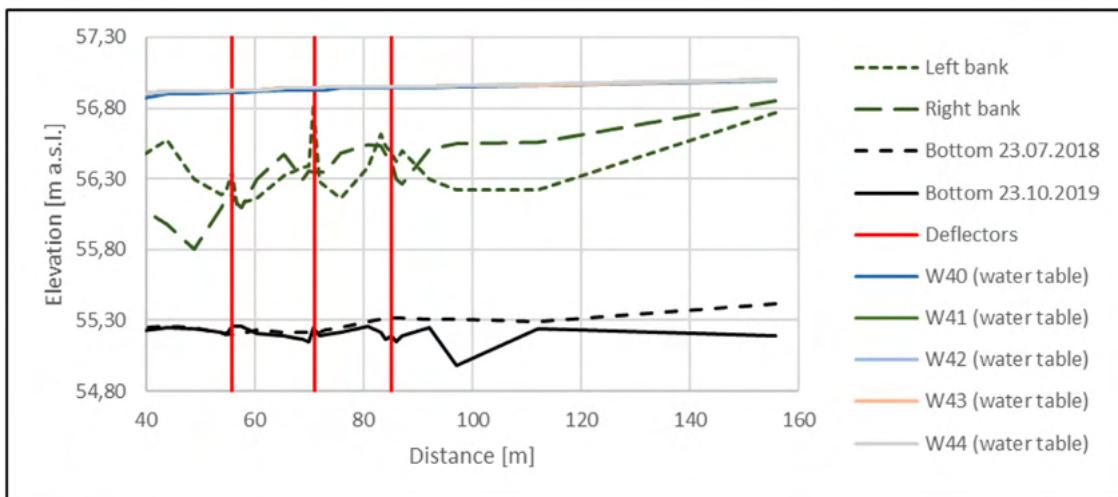
Fig. 10. Comparison of water surface profile for flow for $Q_{1\%}\text{W40- W44}$ (After DC): on the Flinta river.

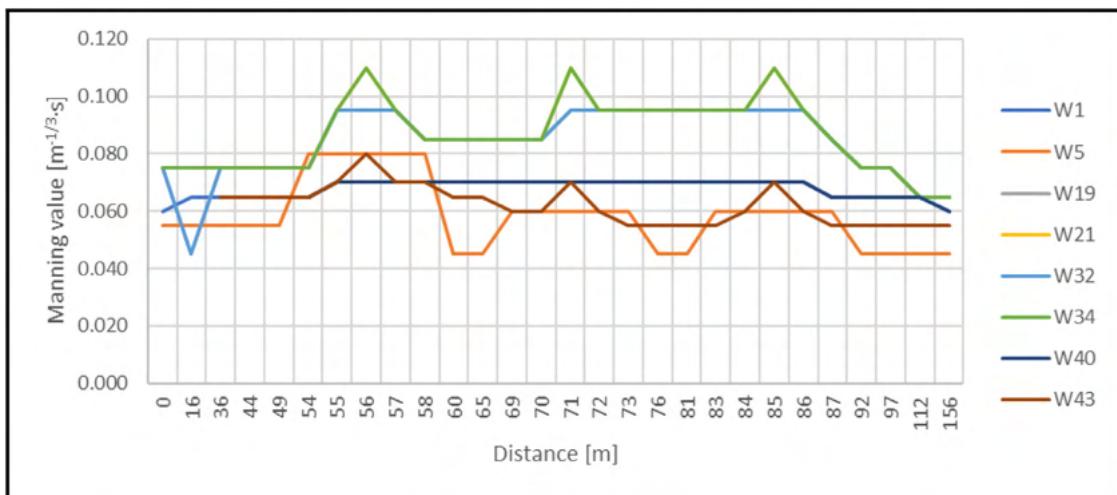
Fig. 11. Changes in average Manning's coefficient values for the Flinta river study region.

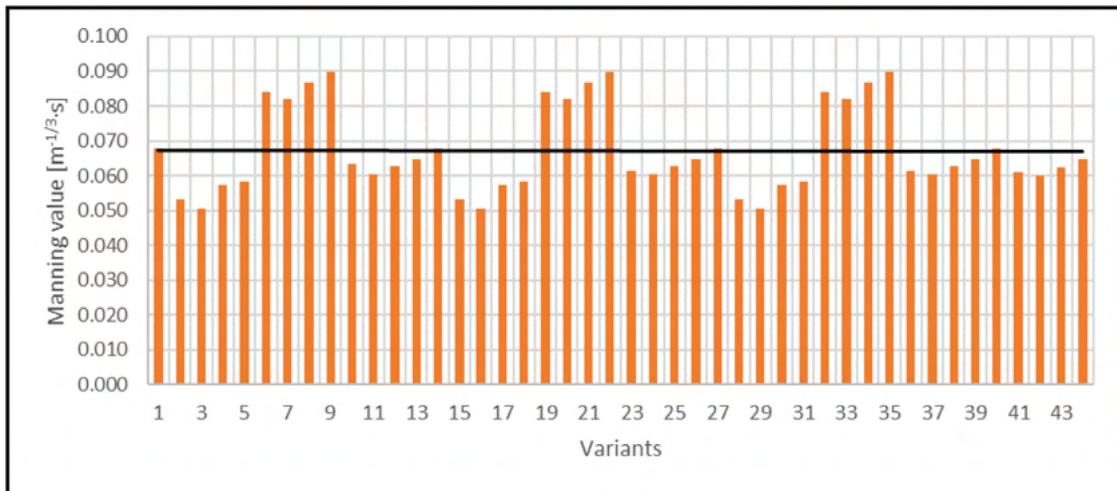
Fig. 12. Average Manning's coefficient values for each variant for the Flinta river study region.

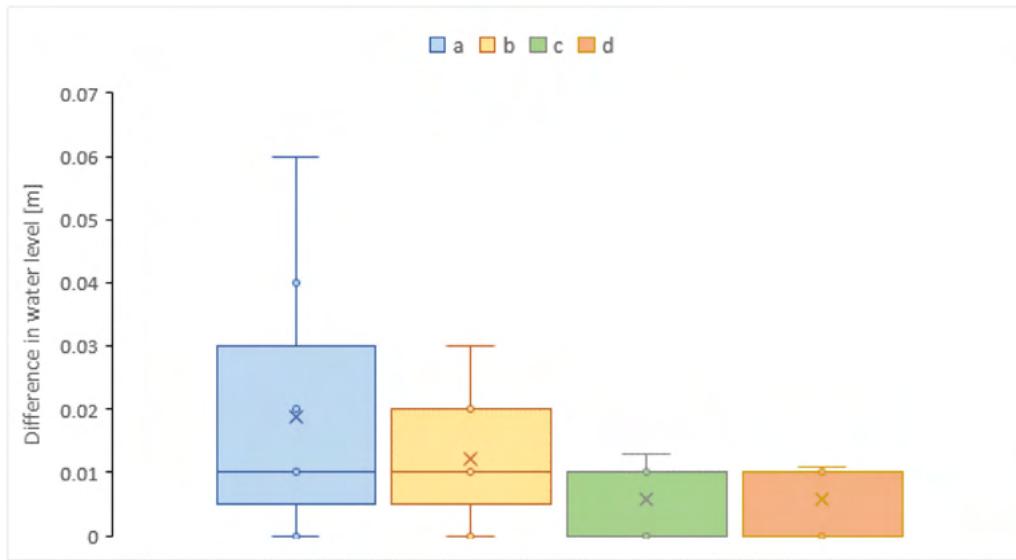
**Fig. 13.** Average and maximum differences between the HEC-RAS model and field measurements of water surface.

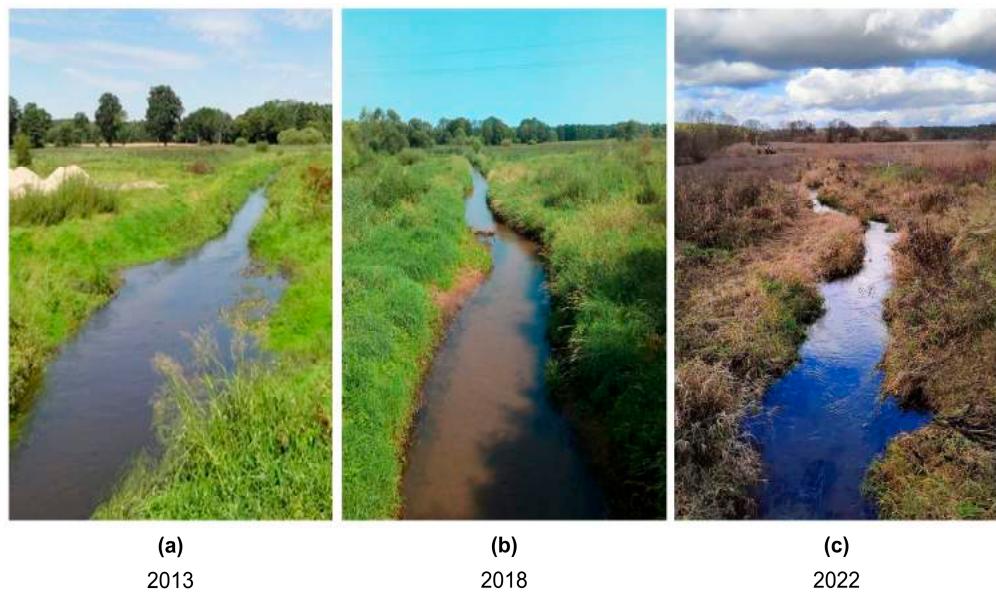
Figure 2. Transformations of section B of the Flinta river (2013—before the introduction of deflectors; 2018—one year after the introduction of the first deflector and one week before the addition of other deflectors; 2022—four years after the introduction of all deflectors).

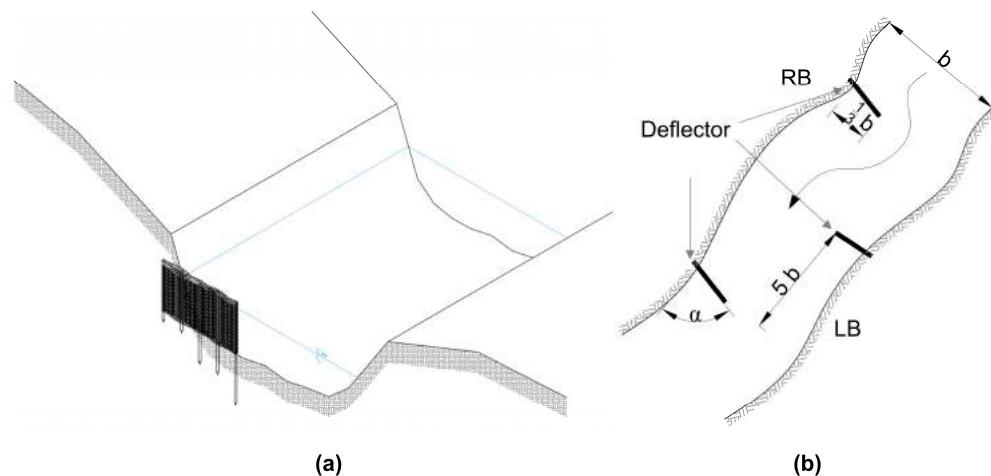
Figure 3. The deflector layout scheme and placement along the studied section of the Flinta River: (a) completed deflector in the river; (b) scheme of the layout of deflectors in the river, b —width of the river, which in the study section varied slightly and ranged from 3 to 4 m. RB—right bank; LB—left bank; α —70–90°.

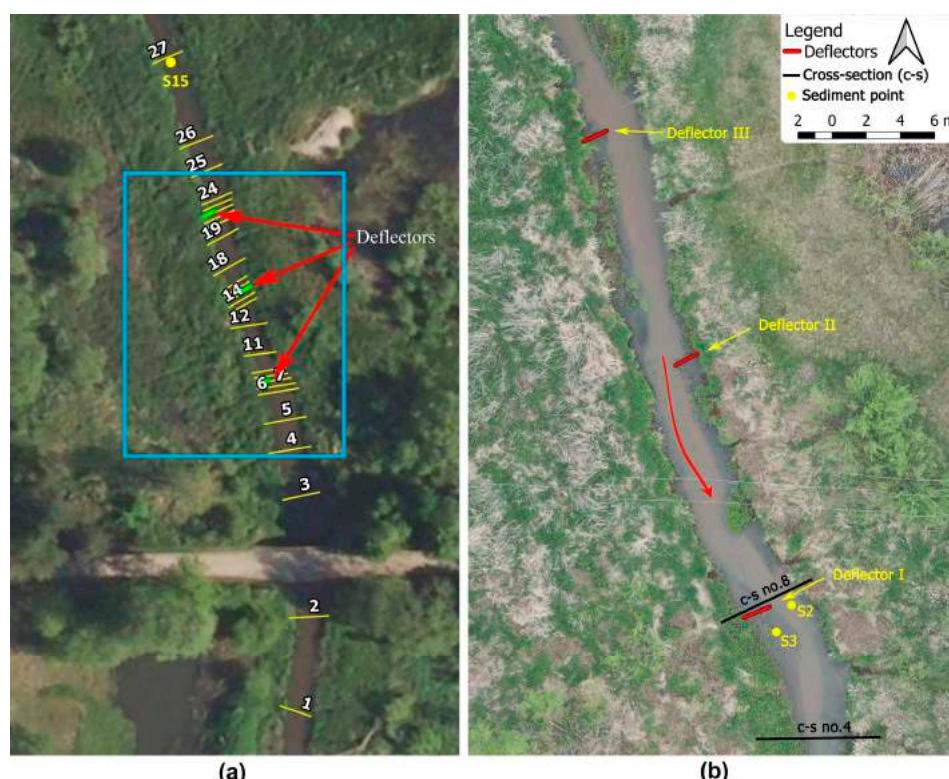
Figure 4. Orthophotomap of the Flinta research study section with deflectors (section B) in 2021, (a) location of cross-sections; (b) enlargement location of deflectors and cross-sections used; S2, S3, S15—samples of the river sediment.

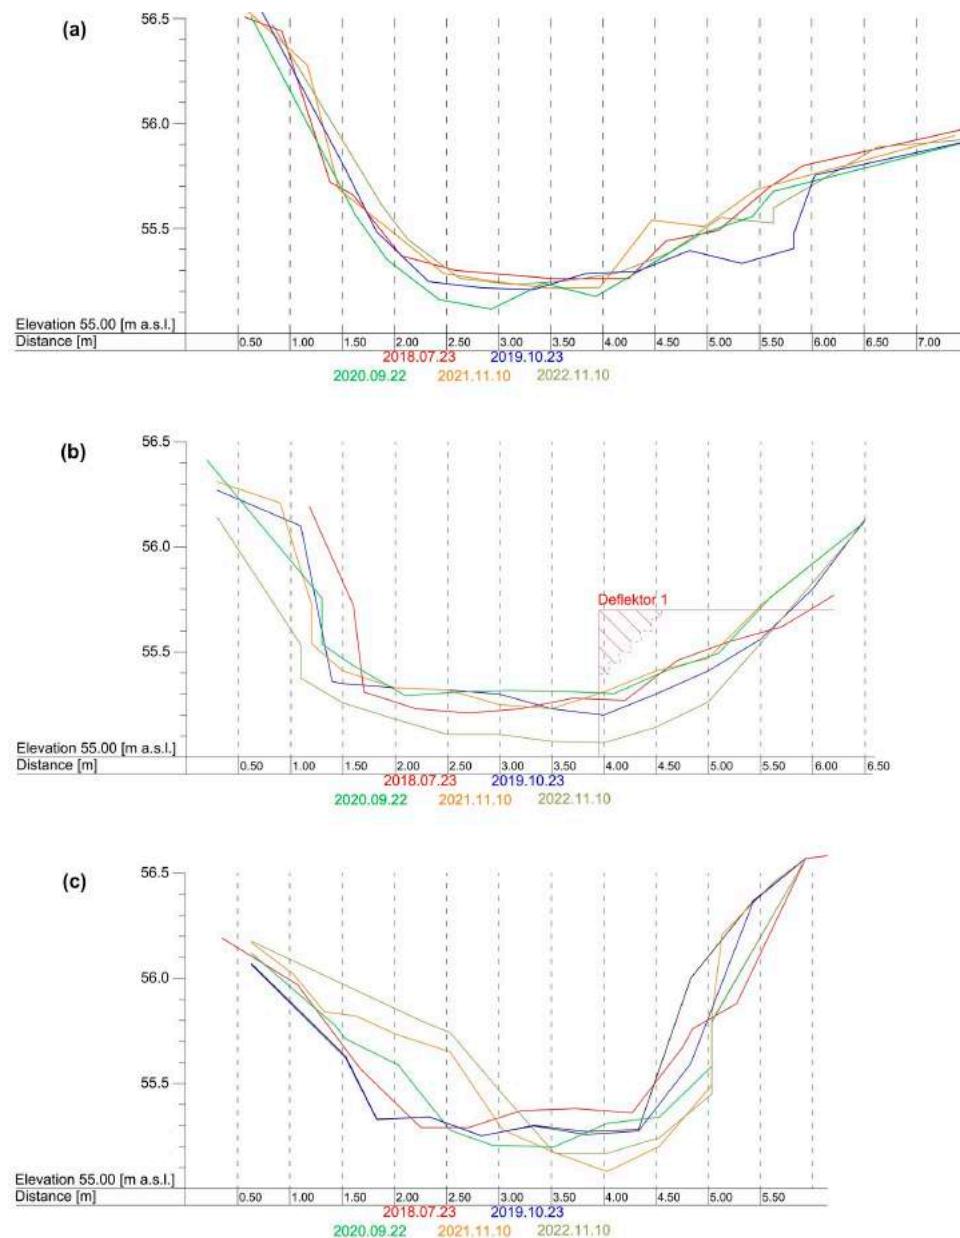
Figure 5. Changes in cross-sections between 2018 and 2022, for cross-sections (a) no. 4, (b) no. 8 and (c) no. 27.

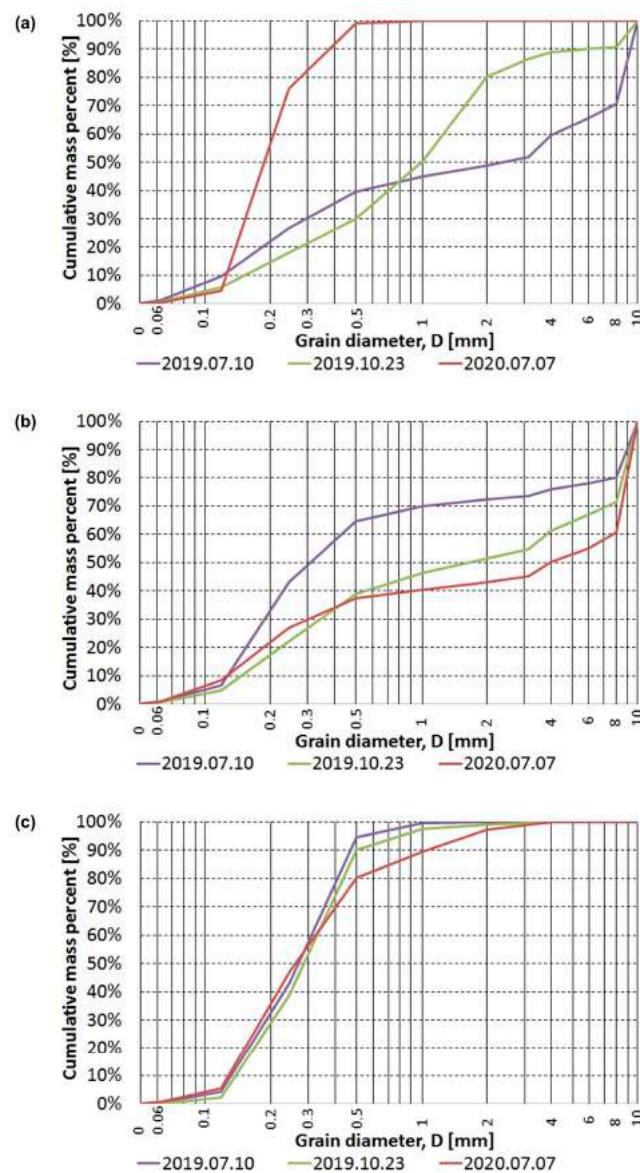
Figure 6. Changes in sediment size: (a) point no. S2—downstream of the deflector cross-section (cross-section no. 6—2 m downstream of the deflector in the water current); (b) point no. S3—cross-section downstream of the deflector (cross-section no. 7—1 m downstream of deflector “in shadow” of deflector); (c) reference point no. S15—in cross-section no. 27.

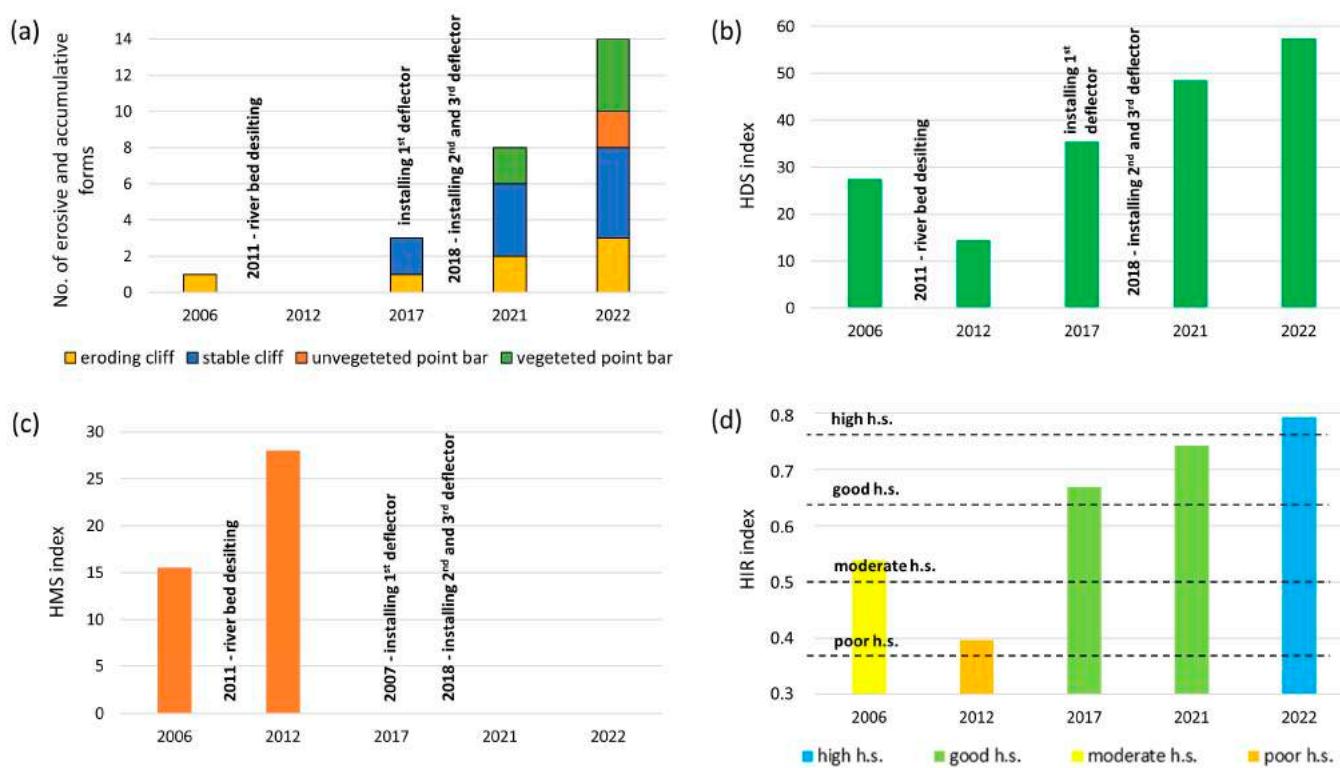
Figure 7. Time variability of selected hydromorphological parameters within the research section with deflectors: (a) number of erosive and accumulative forms; (b) HDS index; (c) HMS index; (d) HIR index; h.s.—hydromorphological status.

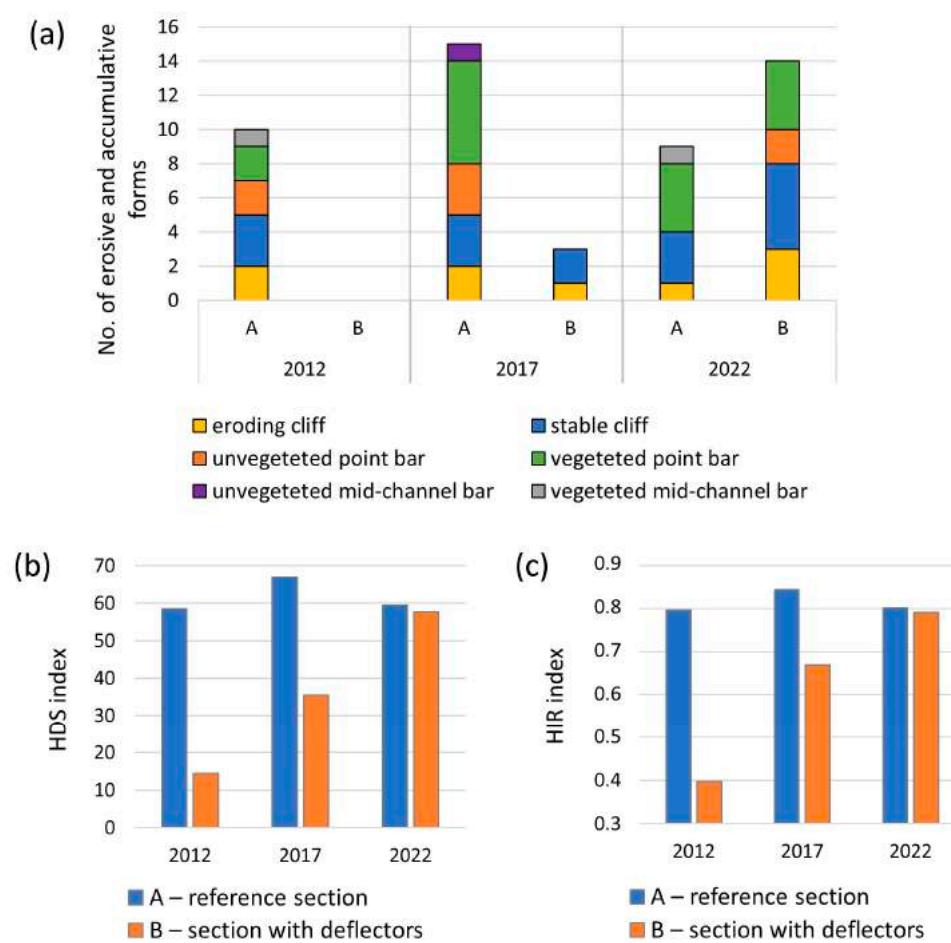
Figure 8. Comparison of the variability over time of selected hydromorphological parameters between the section with the deflectors and the comparative one: (a) number of erosive and accumulative forms (A—reference section, B—section with deflectors); (b) HDS index; (c) HIR index.

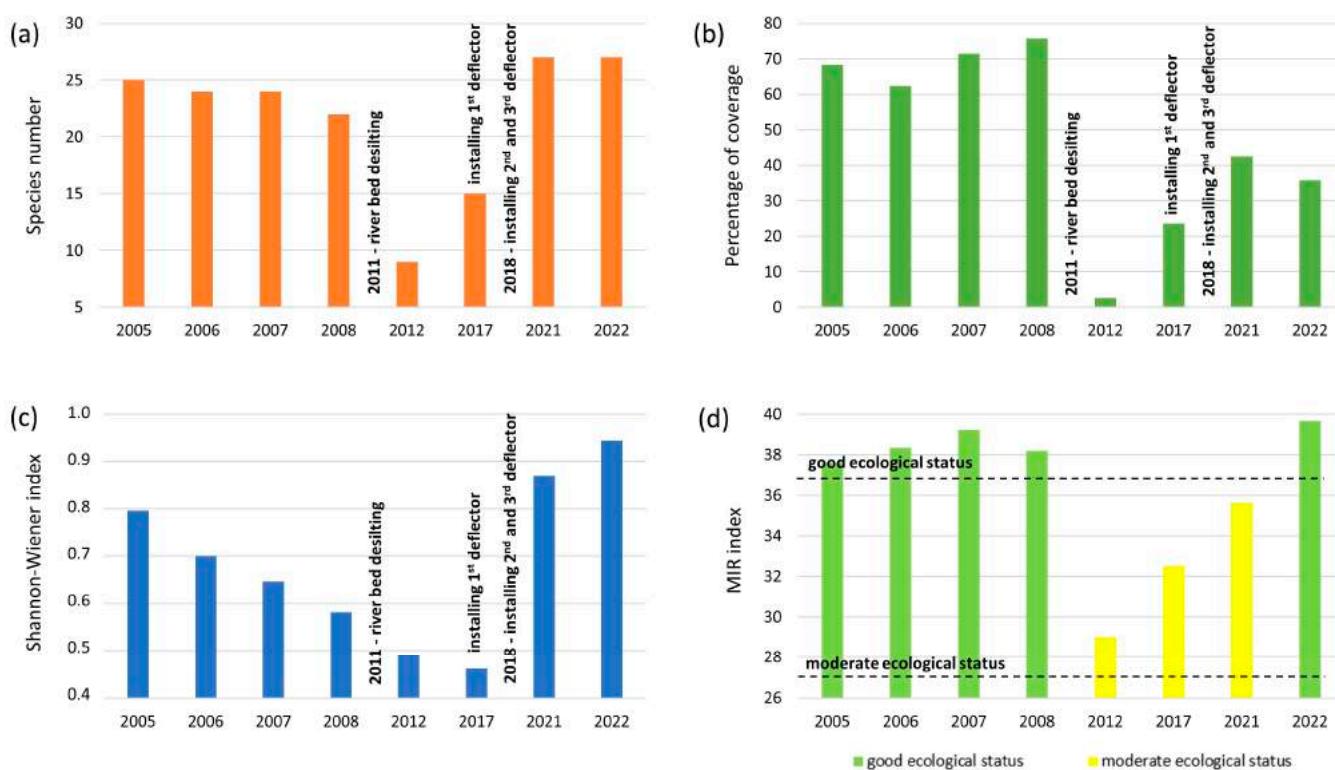
Figure 9. Time variability of selected macrophytes parameters within the research section with deflectors: (a) species number; (b) percentage of coverage; (c) Shannon–Wiener index; (d) MIR index.

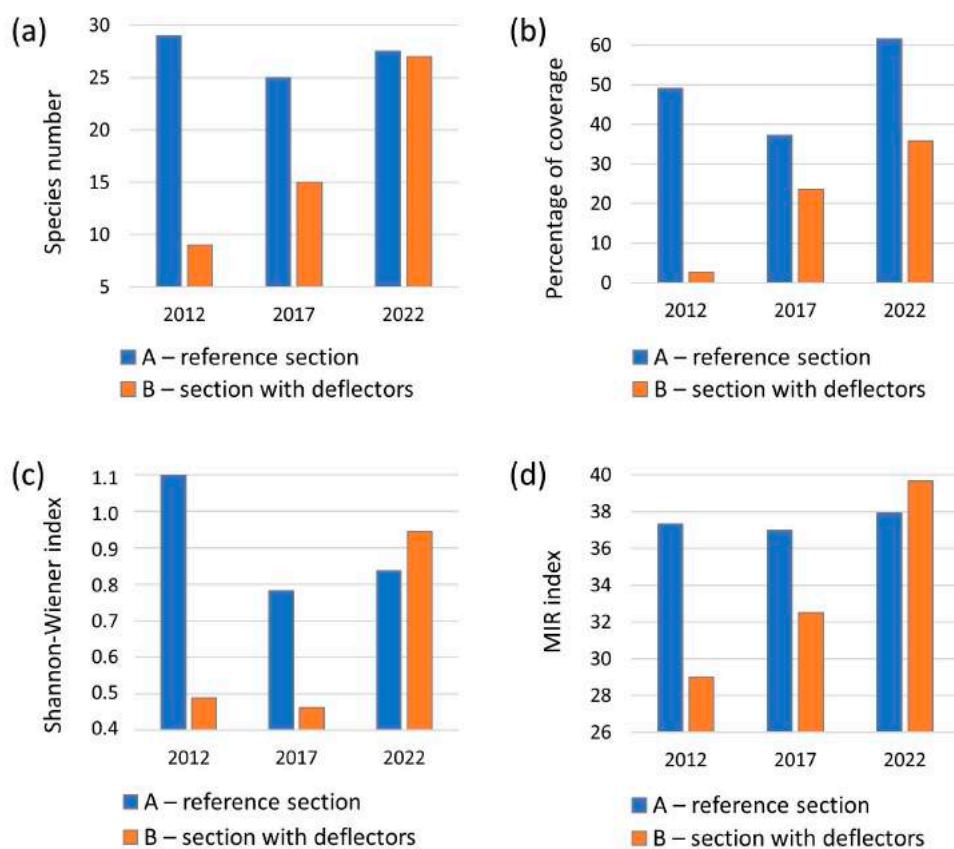
Figure 10. Comparison of the variability over time of selected macrophyte parameters between the section with the deflectors and the comparative one: (a) species number; (b) percentage of coverage; (c) Shannon–Wiener index; (d) MIR index.

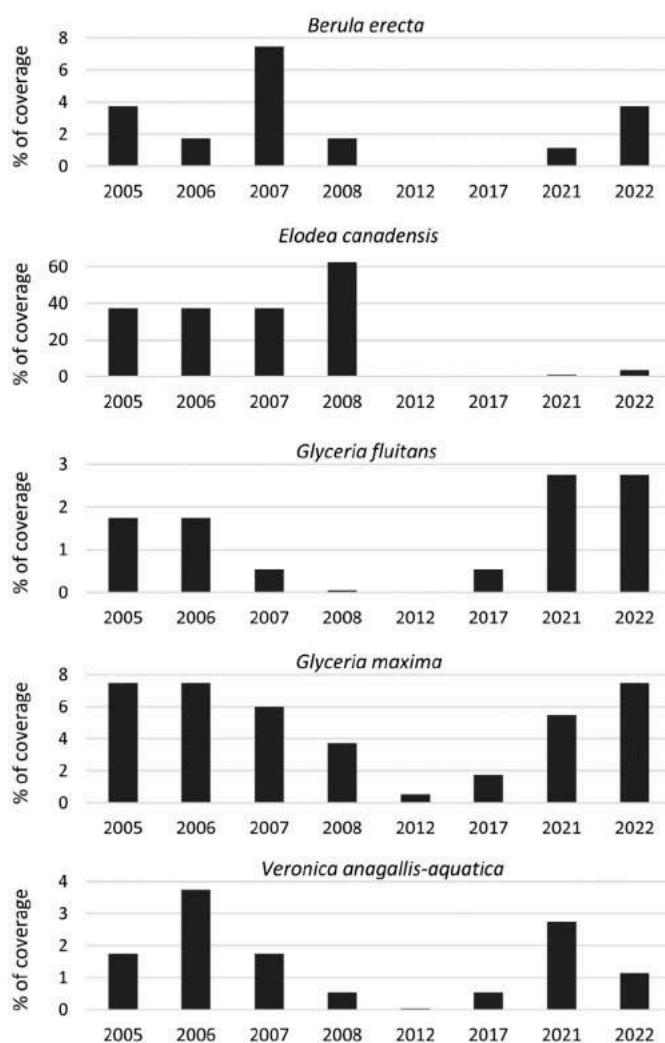
Figure 11. Changes in the coverage of the most important species of macrophytes in the section with deflectors.

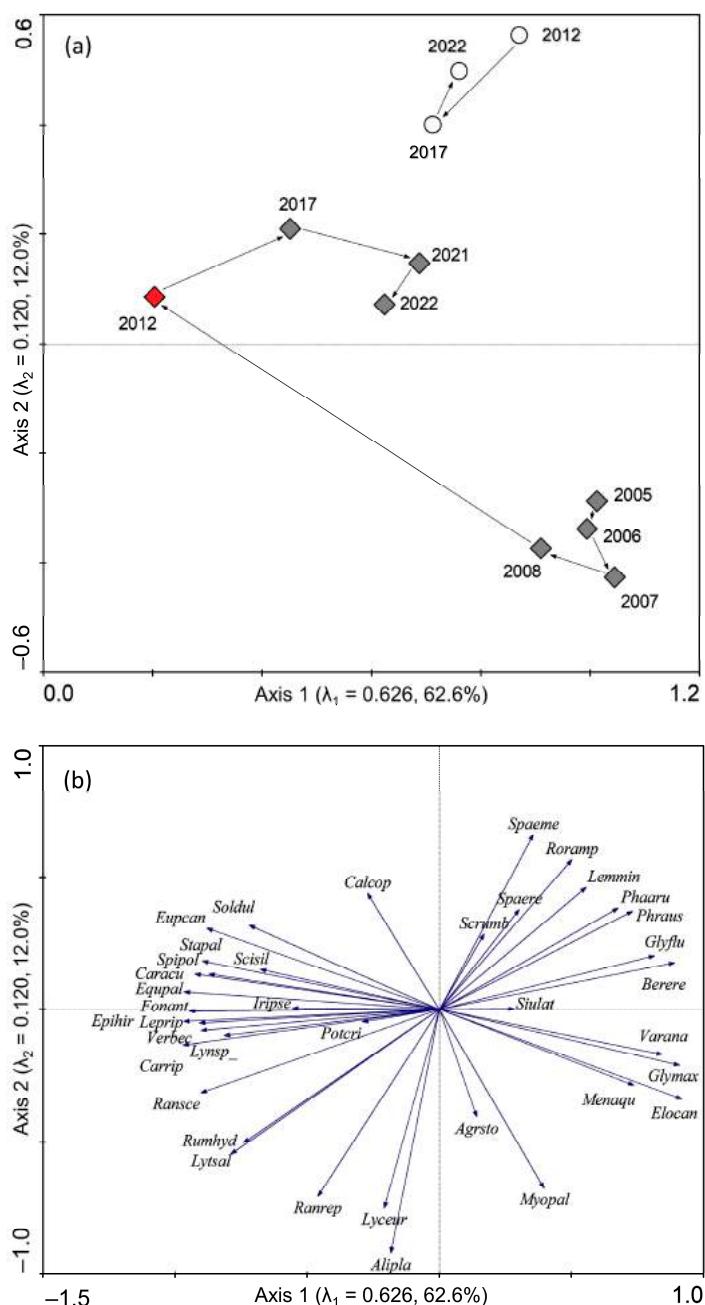
Figure 12. PCA ordination diagram of changes in the taxonomic structure of macrophytes in the years 2005–2022. (a) Scatter plot—sites: diamonds—section with deflectors; circles—comparative section. (b) Scatter plot—species: Agrsto—*Agrostis stolonifera*; Alipla—*Alisma plantago aquatica*; Berere—*Berula erecta*; Calcop—*Callitrichie cophocarpa*; Caracu—*Carex acutiformis*; Carrip—*Carex riparia*; Elocan—*Elodea canadensis*; Epihir—*Epilobium hirsutum*; Equpal—*Equisetum palustre*; Eupcan—*Eupatorium cannabinum*; Fonant—*Fontinalis antipyretica*; Glyflu—*Glyceria fluitans*; Glymax—*Glyceria maxima*; Iripse—*Iris pseudacorus*; Lemmin—*Lemna minor*; Leprip—*Leptodictyum riuparium*; Lyceur—*Lycopus europaeus*; Lynsp—*Lyngbya sp.*; Lytsal—*Lythrum salicaria*; Menaqu—*Mentha aquatica*; Myopal—*Myosotis palustris*; Phaaru—*Phalaris arundinaceae*; Phraus—*Phragmites australis*; Potcri—*Potamogeton crispus*; Ranrep—*Ranunculus repens*; Ransce—*Ranunculus sceleratus*; Roramp—*Rorippa amphibia*; Rumhyd—*Rumex hydrolapathum*; Scisil—*Scirpus sylvaticus*; Scrumb—*Scrophularia umbrosa*; Siulat—*Sium latifolium*; Soldul—*Solanum dulcamara*; Spaeme—*Sparganium emersum*; Spaere—*Sparganium erectum*; Spipol—*Spirodela polyrhiza*; Stapal—*Stachys palustris*; Verana—*Veronica anagallis-aquatica*; Verbec—*Veronica beccabunga*.

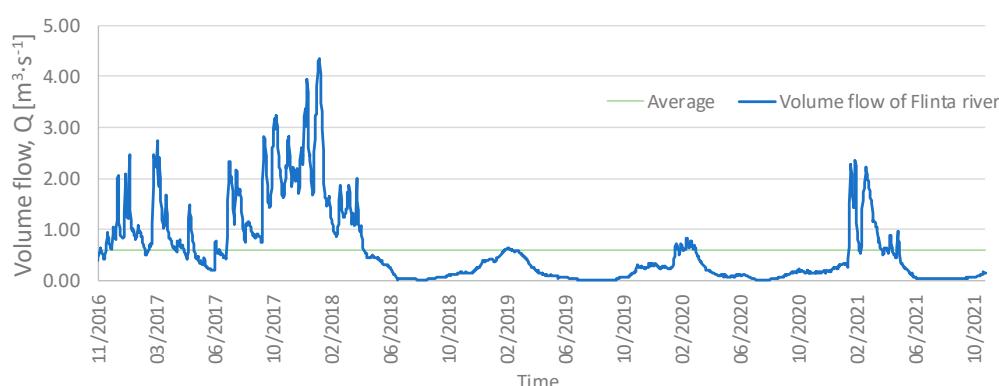
Figure 13. Hydrogram for the period November 2016–October 2021.

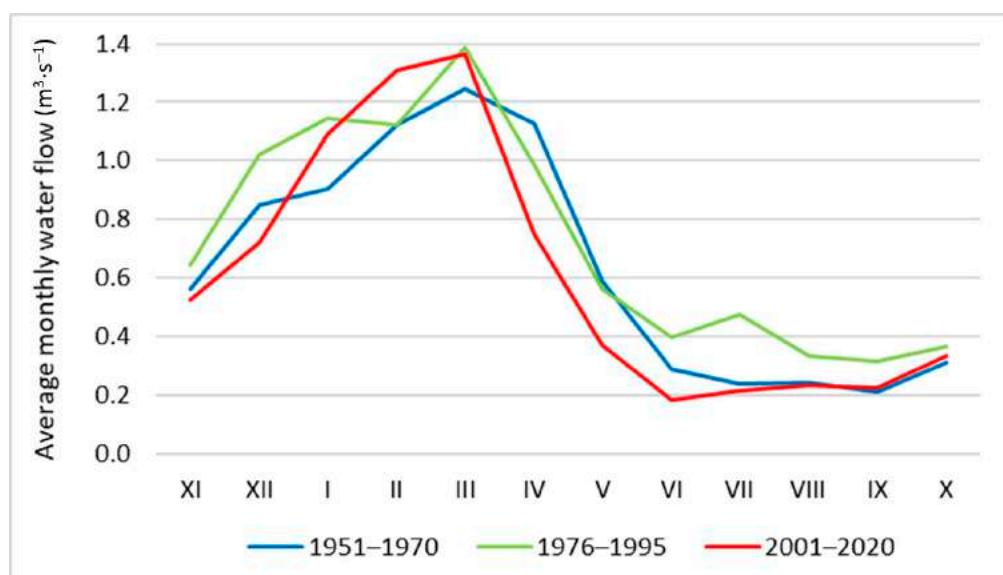
Figure 14. The variability of monthly average water flows in the Flinta River since the mid-20th century.

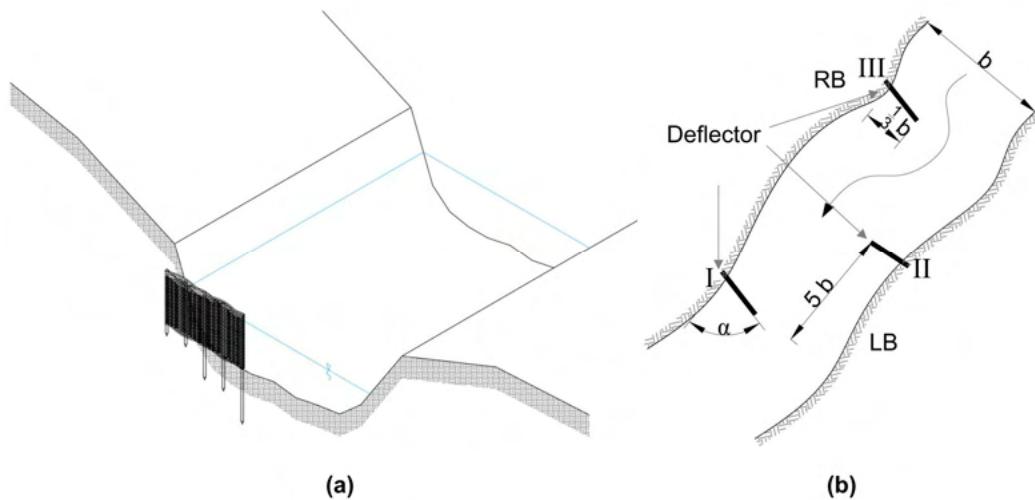
Figure 2. The deflector layout scheme and placement along the studied section of the Flinta River: (a) completed deflector in the river; (b) scheme of the layout of deflectors in the river, b —width of the river, which varied slightly and ranged from 3 to 4 m in the study section. RB—right bank; LB—left bank; $\alpha=70\text{--}90^\circ$, I, II, III—numbers of deflectors [12].

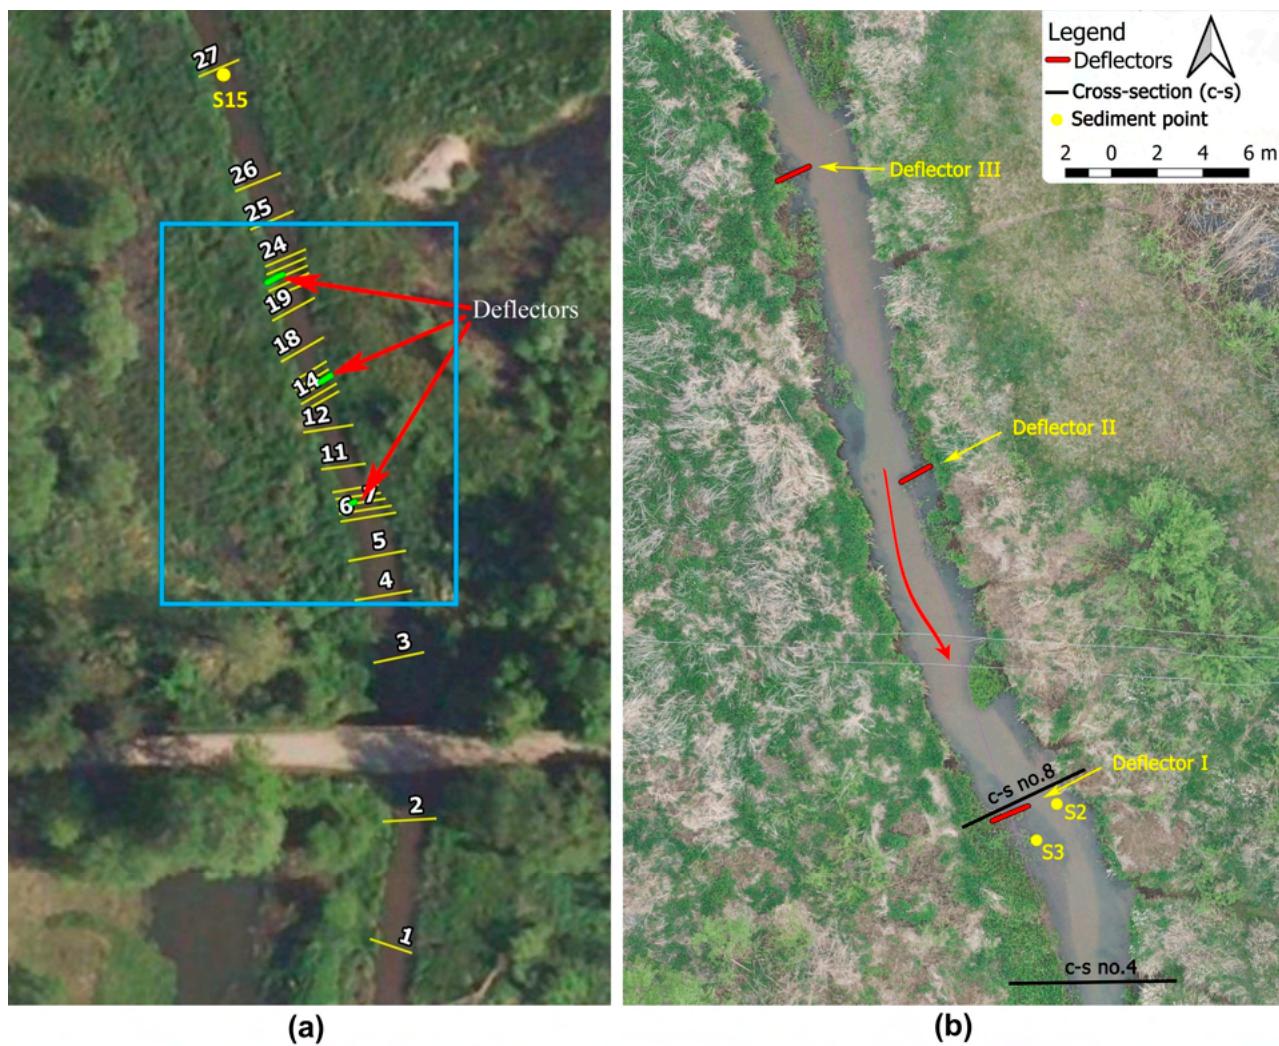
Figure 3. Orthophoto of the Flinta research study section with deflectors in 2021: (a) location of cross-sections; (b) enlargement location of deflectors and cross-sections used; S2, S3, S15—samples of the river sediment [12].

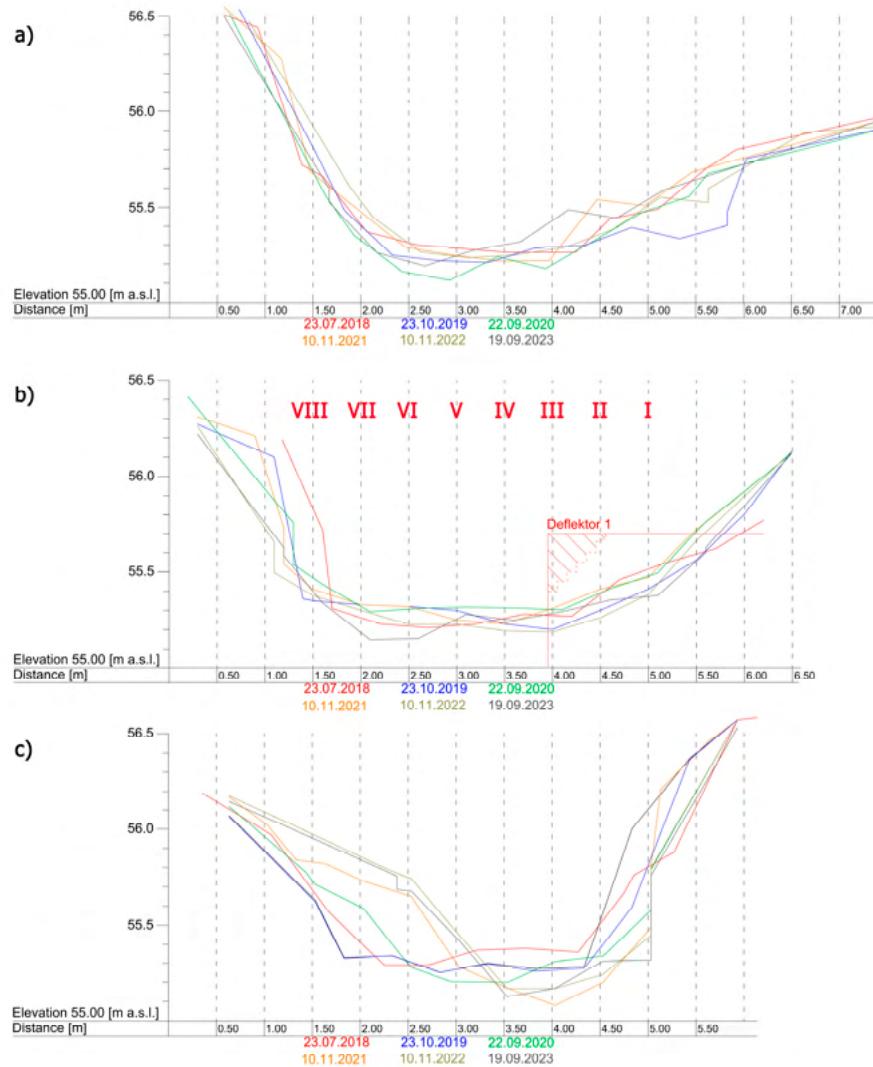
Figure 4. Changes in cross-sections between 2018 and 2023 for cross-sections (a) no. 4, (b) no. 8, and (c) no. 27. Red numbers I–VIII—hydrometric verticals [12] (with modifications).

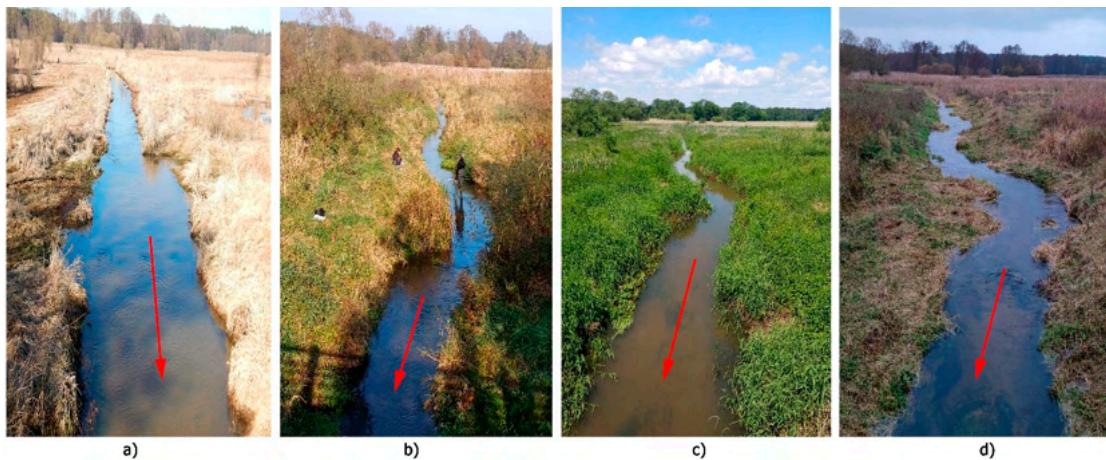
Figure 5. Changes to the Flinta River channel in the surveyed section between 2013 and 2023 for (a) March 2013, (b) October 2019, (c) June 2021, and (d) November 2023, red arrow – direction of water flow.

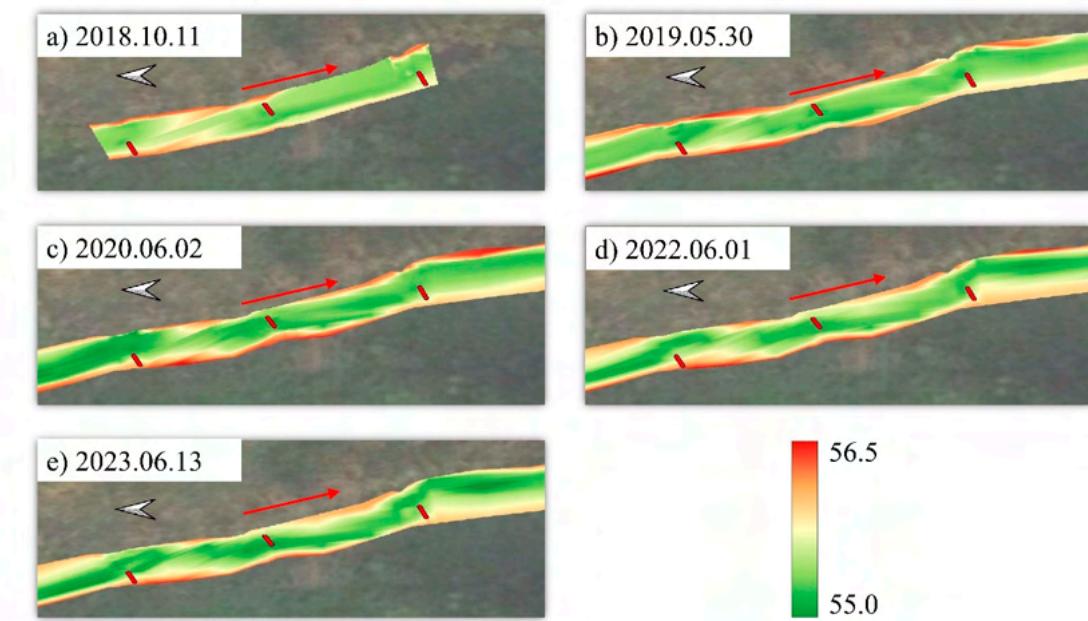
Figure 6. Changes in terrain and channel bottom elevations based on survey measurements from 2018 to 2023 (m a.s.l.), red line – deflectors, red arrow – direction of water flow.

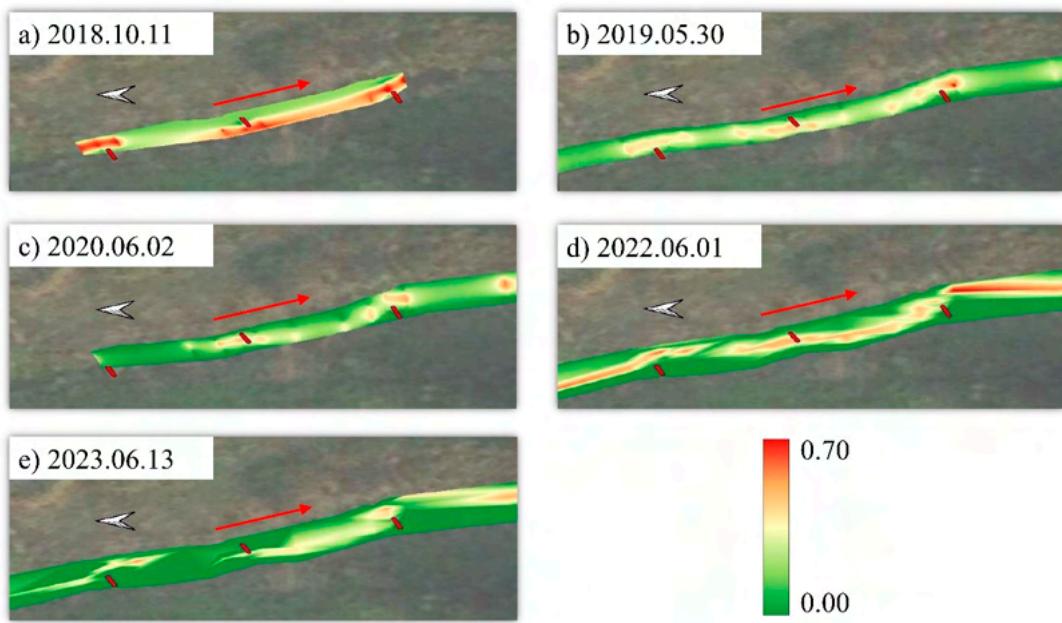
Figure 7. Velocity distributions in the channel based on hydrometric measurements from 2018 to 2023 (values in $\text{m}\cdot\text{s}^{-1}$), red arrow – direction of water flow.

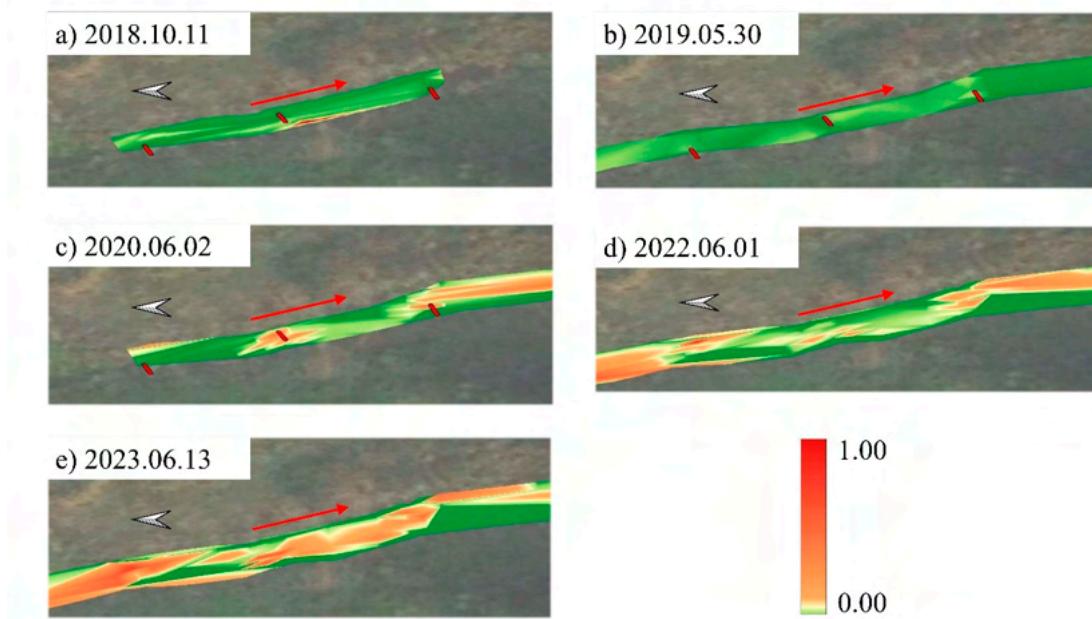
Figure 8. Changes in shear stress in the channel for flows of $0.200 \text{ m}^3 \cdot \text{s}^{-1} \pm 10\%$ in 2018–2023 (values in $\text{N} \cdot \text{m}^{-2}$), red arrow – direction of water flow.

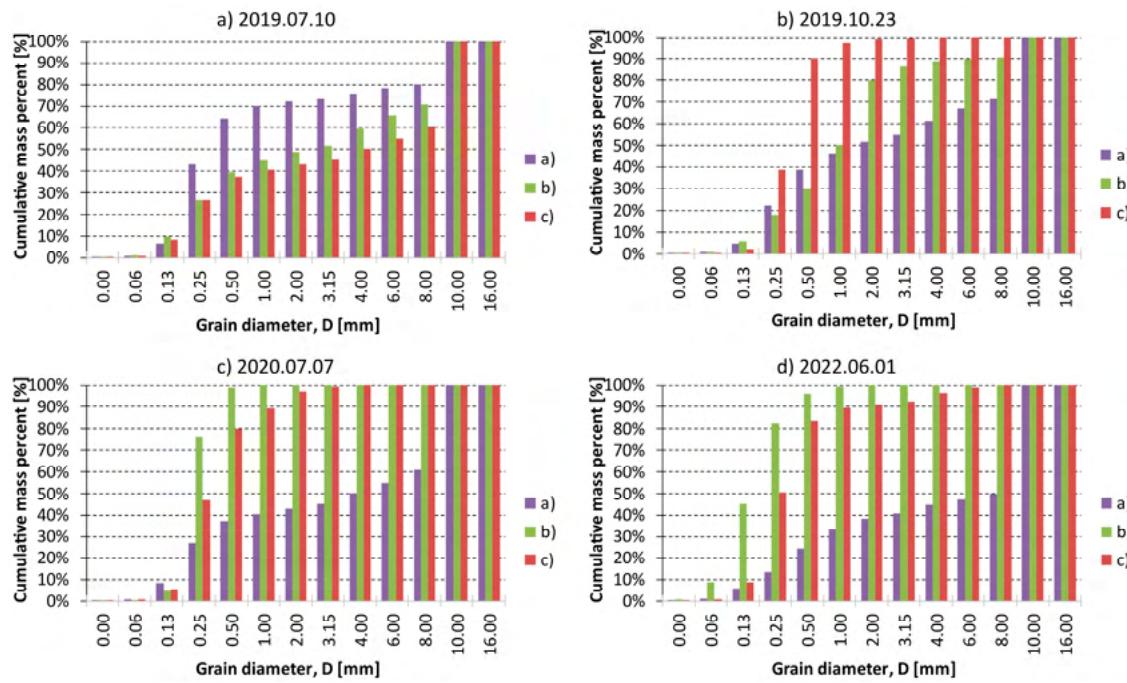
Figure 9. Changes in sediment size: (a) downstream of the deflector cross-section in shadow of deflector; (b) cross-section downstream of deflector in current line; (c) reference point.

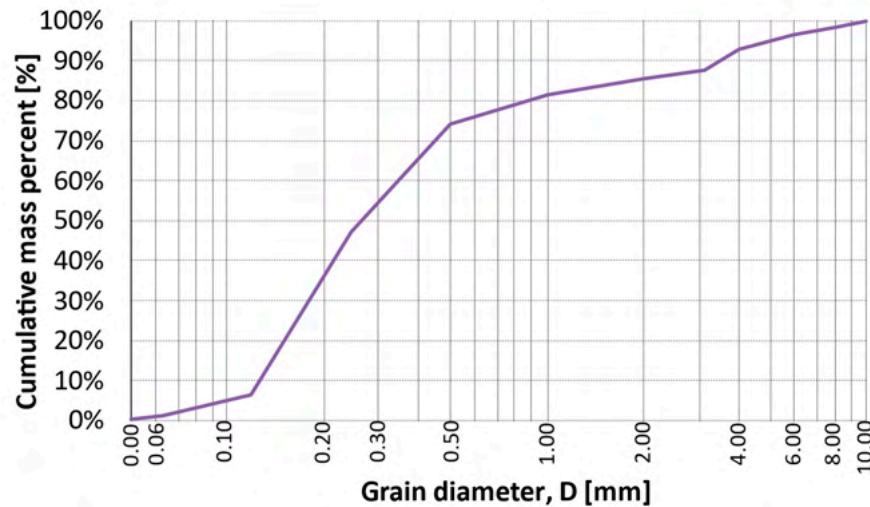
Figure 10. The granulometric composition of bed load on 6 July 2023.

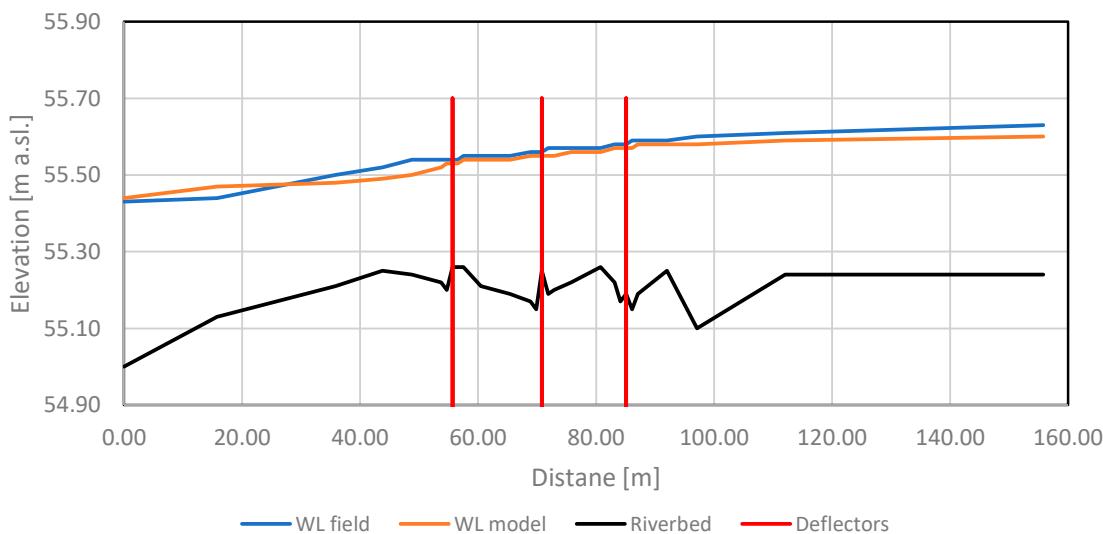
Figure 11. Comparison of water elevations measured on June 13 2023, and the results from the HEC-RAS 2-D model for a measured flow of $0.200 \text{ m}^3 \cdot \text{s}^{-1}$.
